California Department of Forestry and Fire Protection

Review Report of Serious CDF Injuries, Illnesses, Accidents and Near-Miss Incidents

Engine Crew Entrapment, Fatality, and Burn Injuries

**Cedar Fire
CACNF-003056
CACSR-000132**

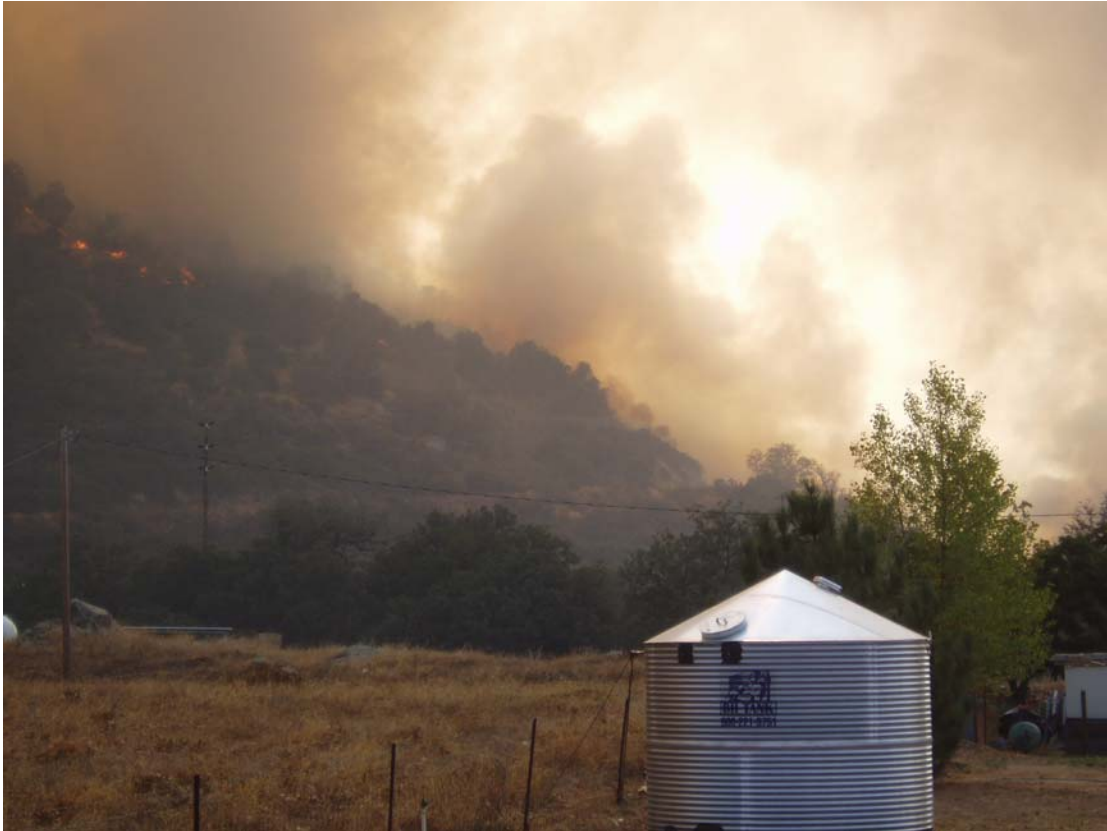
Slop-over Fire after it crossed Highway 78/79; viewed from Santa Ysabel by the crew of Engine 6162. Photo taken by Firefighter-Paramedic Barrett Smith at 9:47 a.m. on 10/29/03.

At 9:47 a.m., S/T 2005A with Novato Engine 6162 observes the fire that has crossed Highway 78/79 between Santa Isabel and the Inaja Memorial. (See photo above) By about 10:20 a.m., S/T 2005A is assigned to do structure protection in the Riverwood Estates. At 10:22 a.m., Firefighter-Paramedic Smith on Engine 6162 takes photos as they drive through the slop-over area. (See photo next page)

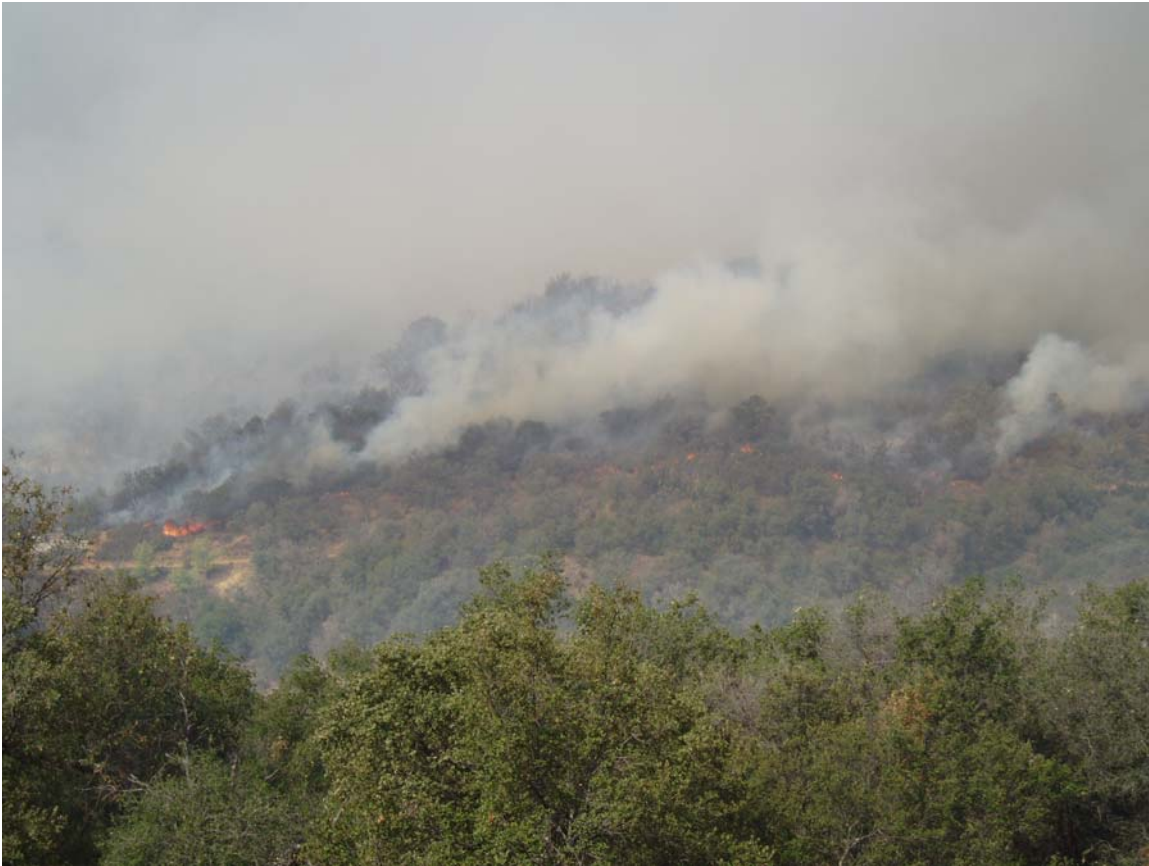
Looking west from Riverwood Estates towards the slop-over above Highway 78/79 at 10:56 a.m. on October 29, 2003. Photo taken by Firefighter-Paramedic Barrett Smith.

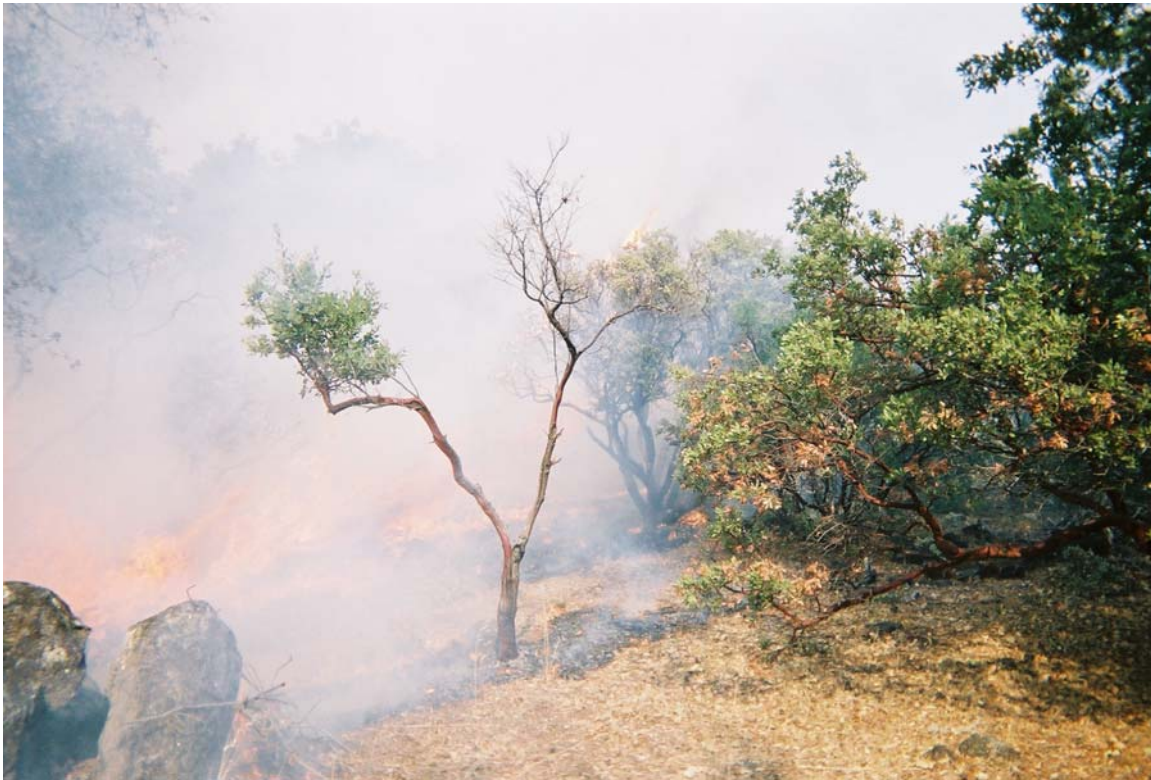
Picture taken by Engineer Kreps of the fire he finds on the ground north of the garage just before he begins to fire-out from this location. This is the same area where Capt. McDonald sees two CDF personnel firing-out at the top of the driveway. View is to the north towards 902 Orchard Road.

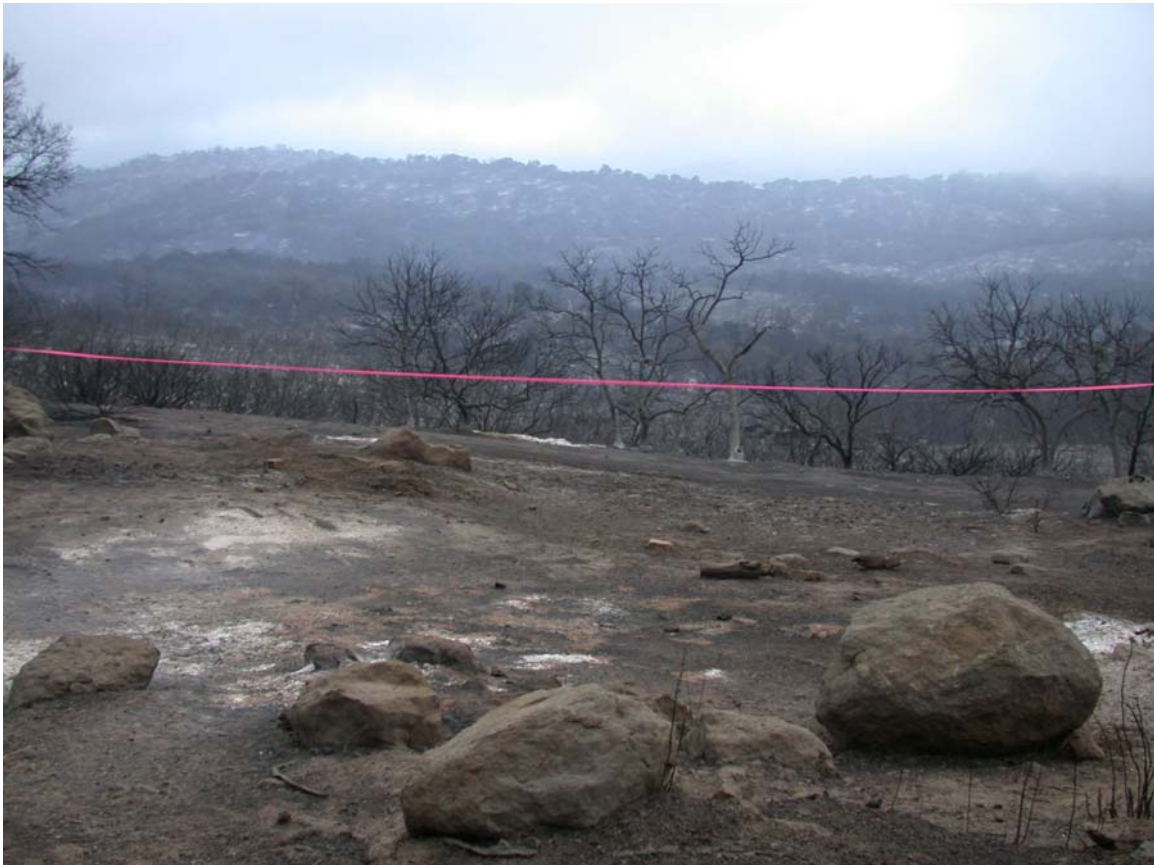
Area below and to the southwest of Engine 6162 where brush had been cleared and the crew of Engine 6162 strip-burned grass stubble. Capt. McDonald had thrown fuses into brush below the clearing.

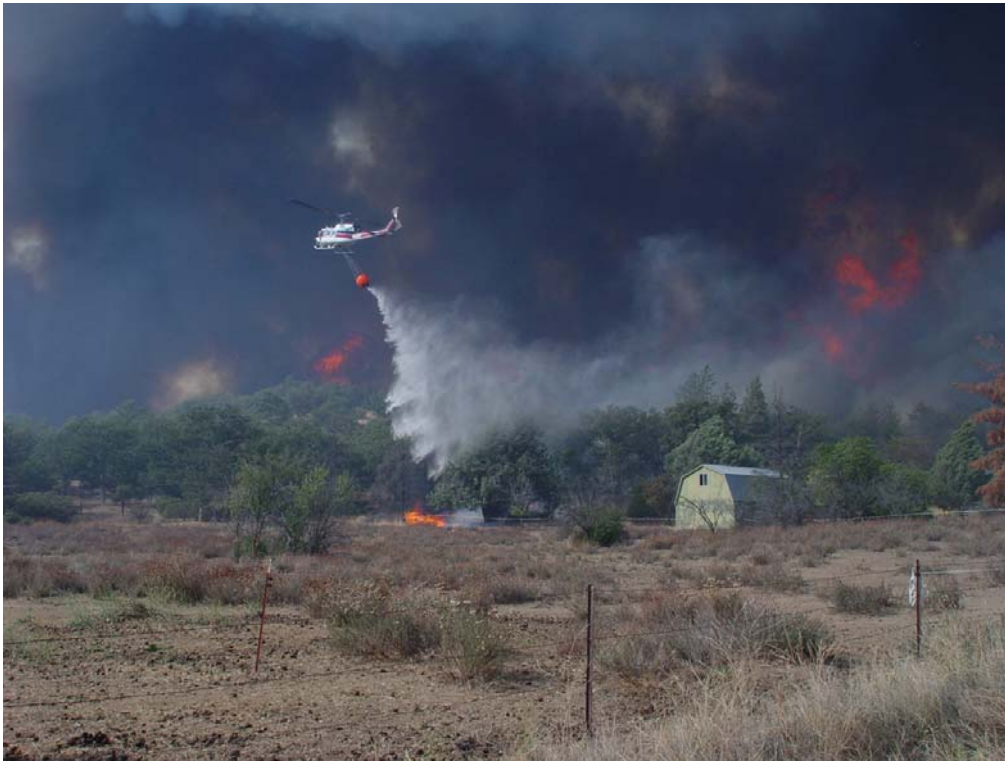
Main fire running from southwest to northeast. Viewed from Orchard Lane near 1038 Orchard. Flames on the right in background are near 930 Orchard Lane.

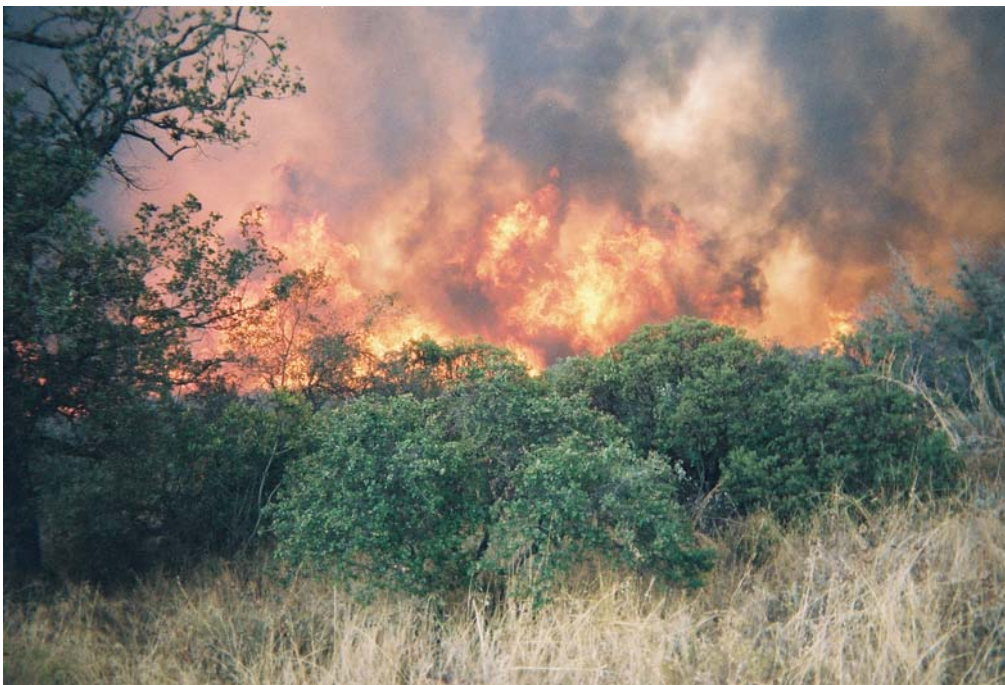
Fire picking up below the crew of Engine 6162 just as they begin to retreat back to the engine from firing-out. Photo taken by Engineer Kreps.

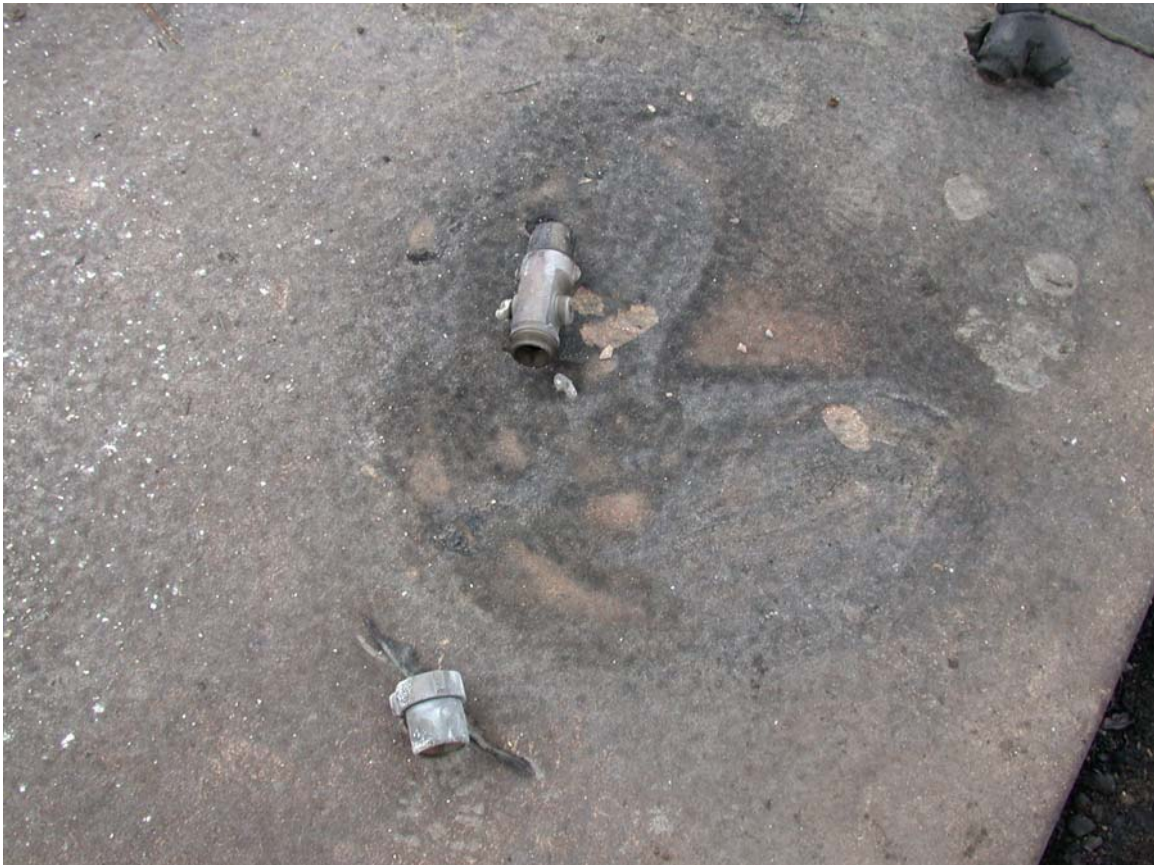
Burnt outline of first 100 feet hose pack dropped near the feet of Engineer Rucker on patio. In-line Tee visible in upper middle portion of photo.

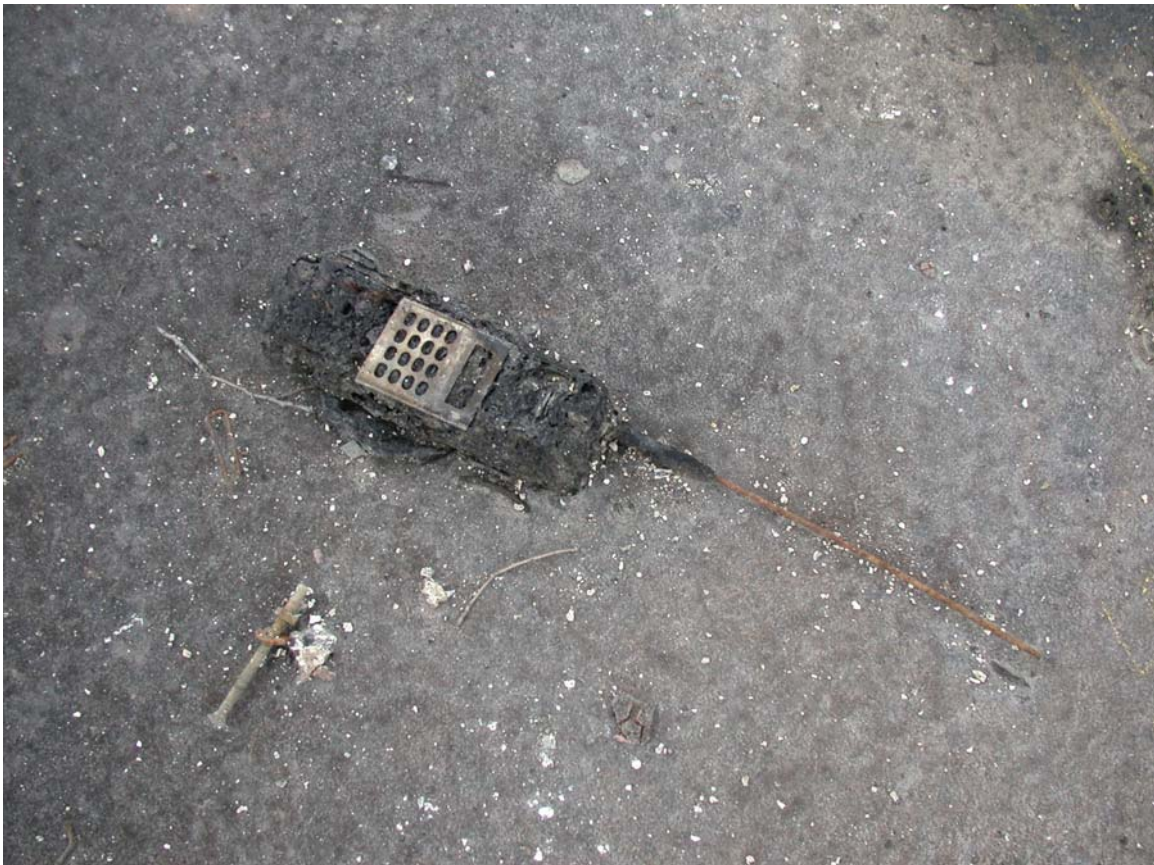
A King portable radio belonging to the Novato Fire District is later found on the ground next to the body of Engineer Rucker on the side nearest the steps. This radio had been carried by Captain McDonald and was being used to transmit on the tactical channel. Captain McDonald has no recollection of making a radio transmission next to Engineer Rucker at this point in time.

King portable radio left on patio just to the west side of Engineer Rucker (between Rucker and patio steps)

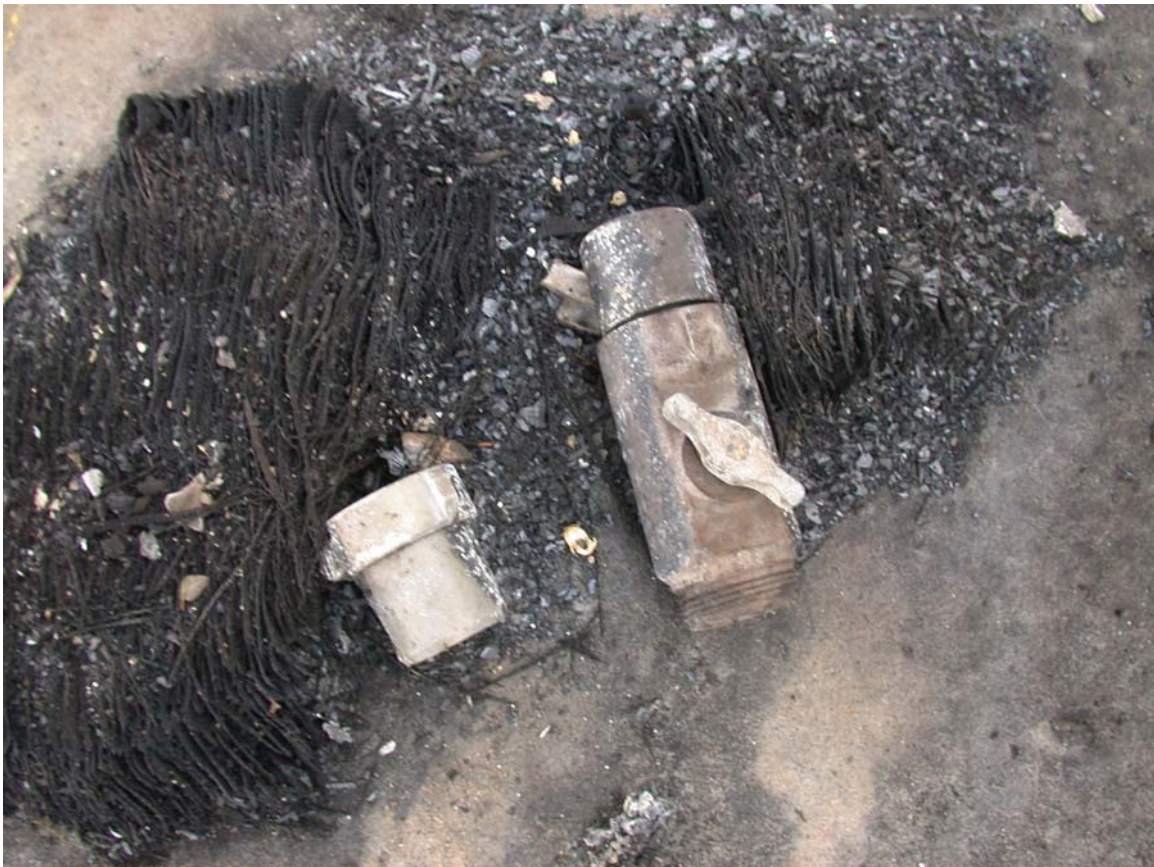
Second 100 feet of hose pack found just above and next to the right shoulder of Engineer Rucker.

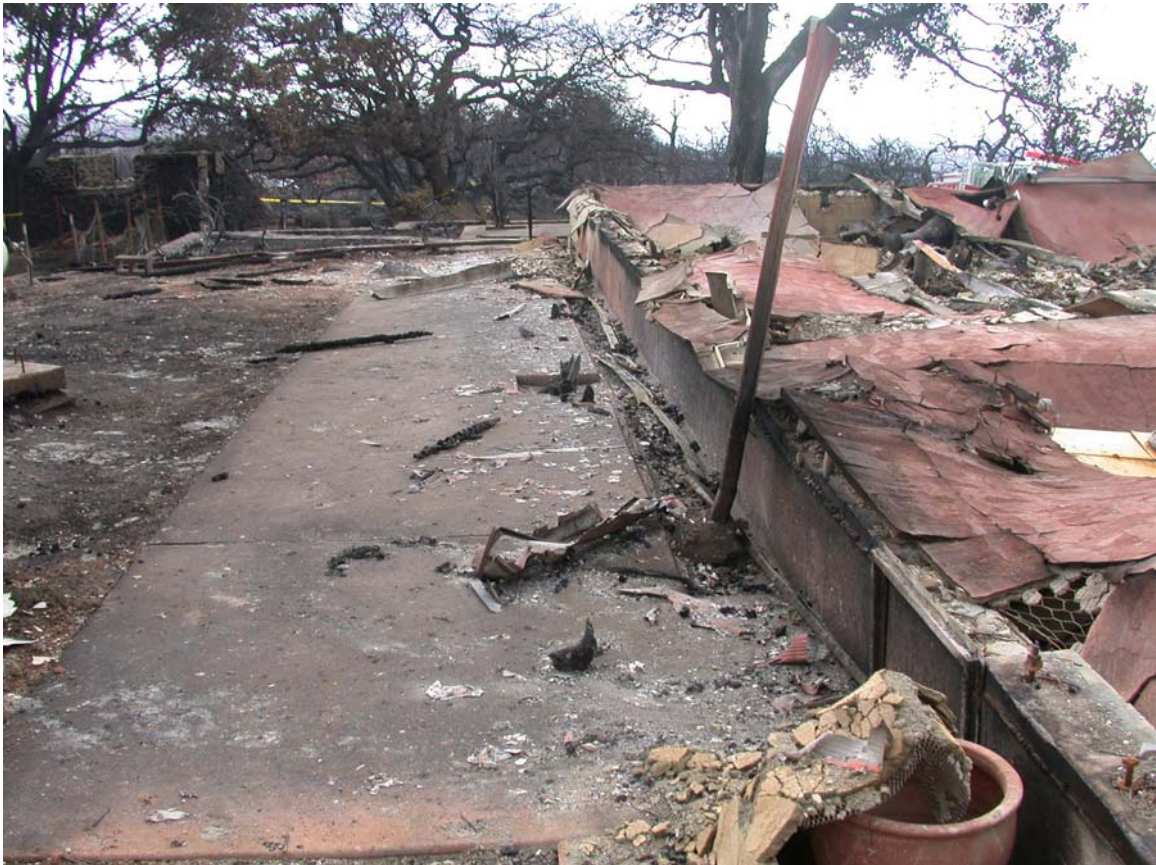
View from near the rear door of the residence looking toward the patio. This is the path taken by the crew after turning the corner from the patio, and the route used to return to look for missing crew members. Tree located in upper right corner of photo is next to the location where Engineer Rucker went down for the third and final time.

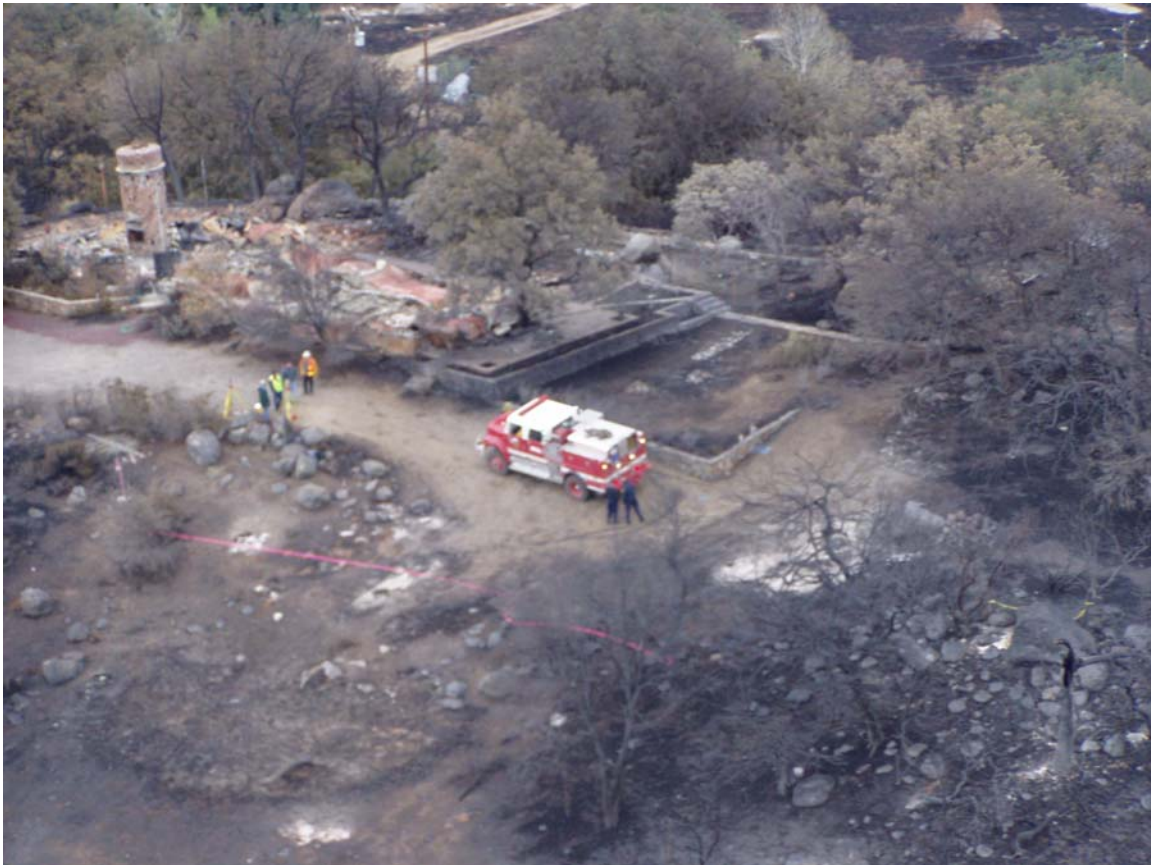
Photo taken after the accident with Engine 6162 placed back into position of where it was during the burn-over. The Engine is facing north. Fired-out area shown in lower left corner of photo. Steps used to access patio are just north of the engine. Engineer Rucker's body was found just below tree on patio.

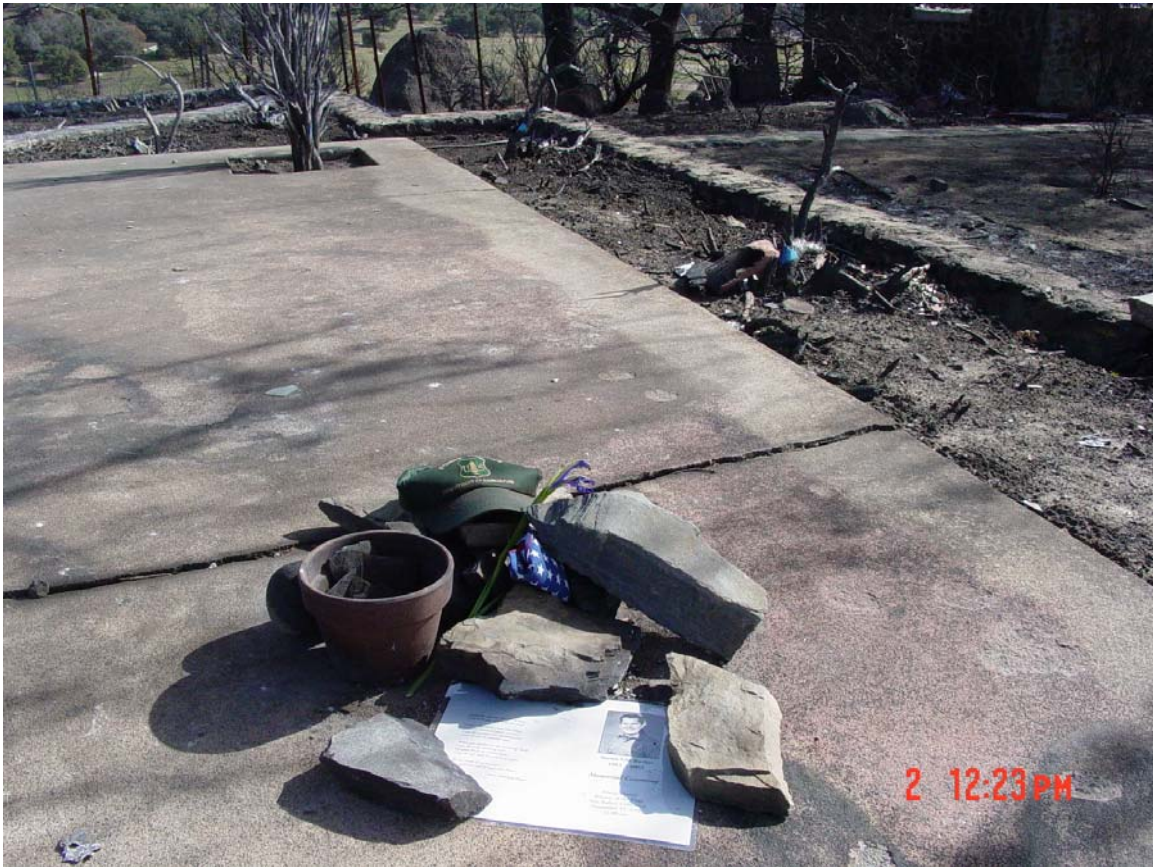
The patio on the south end of the house was surrounded on the west, south, and east sides by a juniper hedge. The linear burn pattern along the south edge of the patio concrete appears to indicate that the juniper hedge was continuous, and encroached approximately one foot over the southern patio surface. It also extended around both southwest and southeast corners of the patio and on both sides of the steps to the driveway. The perimeter of the hedge, as estimated from patio burn patterns, is shown on Figure 2 and Figure 4. The extent of recent pruning of the Juniper hedge is unknown and the height of the hedge is not estimated. A tall cylindrical shaped Juniper-like coniferous shrub was planted in each of the “tree well” planting boxes shown at the two corners of the patio in Figure 4. The canopy of a 16-inch diameter oak tree covers the entire patio as shown in aerial photograph Figure 8.

Photo of the accident site patio at the south end of the 920 Orchard Lane house. Juniper hedge stumps can be seen between the southern edge of the patio and the rock wall on the right, and in the triangular planting area adjoining the eastern end of the patio. One of the two shrub stumps located in the “tree wells” (shown in Figure 4) can be seen at the top of the photo. The concrete patio burn pattern, indicating the presence of a continuous Juniper hedge encroaching over the patio, is shown along the right edge of the patio*. The concrete patio burn spall marks indicated in Figures 4 & 5 can be seen around the memorial items in the center of the picture (photo reference - Foote item #51 Tab Section 122).

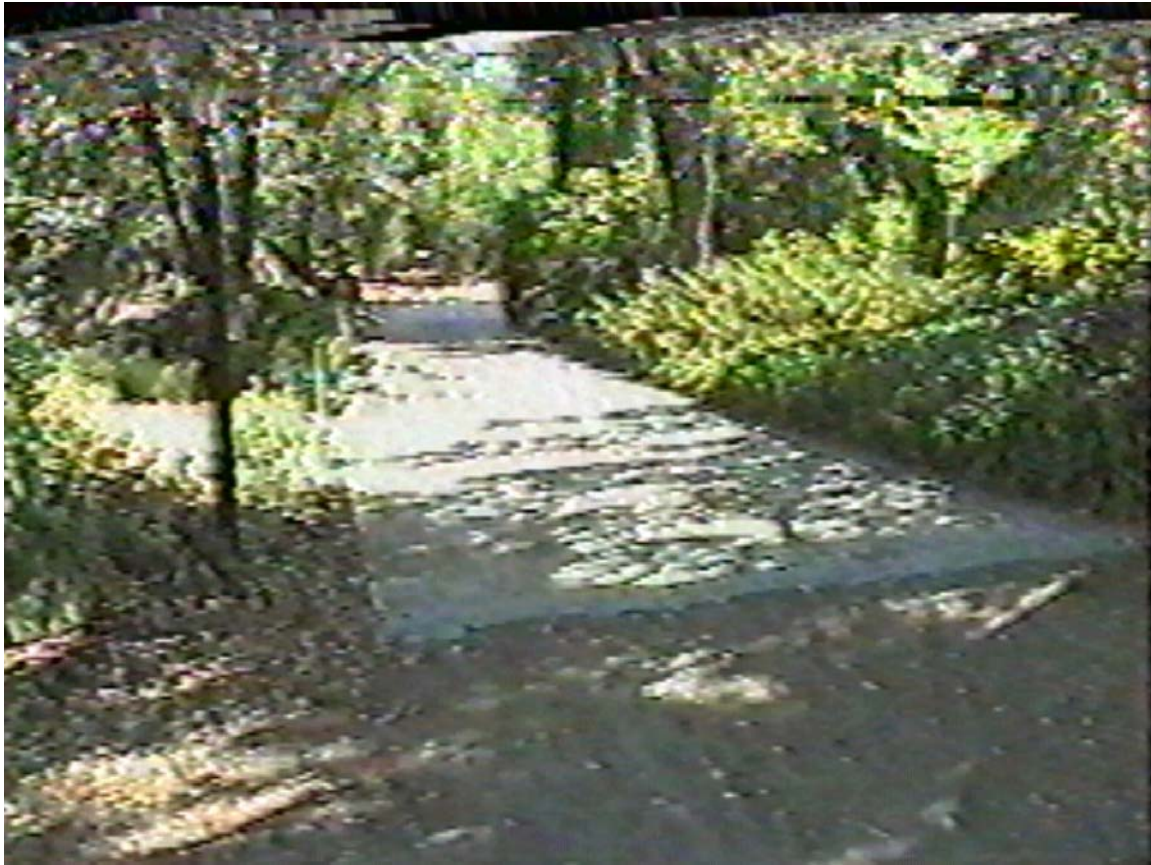
vegetation to the readily ignitable structural materials of the house deck. The landscaped area in the 110 feet north of the house to the driveway was denser than elsewhere on the property. Another row of burned out shrubs lines the southern edge of the driveway directly north of the house. The June 2001 video photograph of the driveway shows continuous surface fuels to the right of the driveway looking north, although some of this could have been pruned in the intervening years. There is 90+% closure of the conifer and oak tree canopy over this area. There are also rock retaining walls, paved walking paths, and patio areas throughout the area with patches of unburned surface fuels.

Photo from the 2001 Lis family video looking north at the driveway. Continuous, heavy, landscaped surface fuels can be seen on the right side of the driveway above and in the post fire photo (Tab Section 108 photo item #41) of the same area.
