Accident Investigation Report

CDF HELITACK CREW 404 BURNOVER

Tuolumne Fire

CA-STF-2191

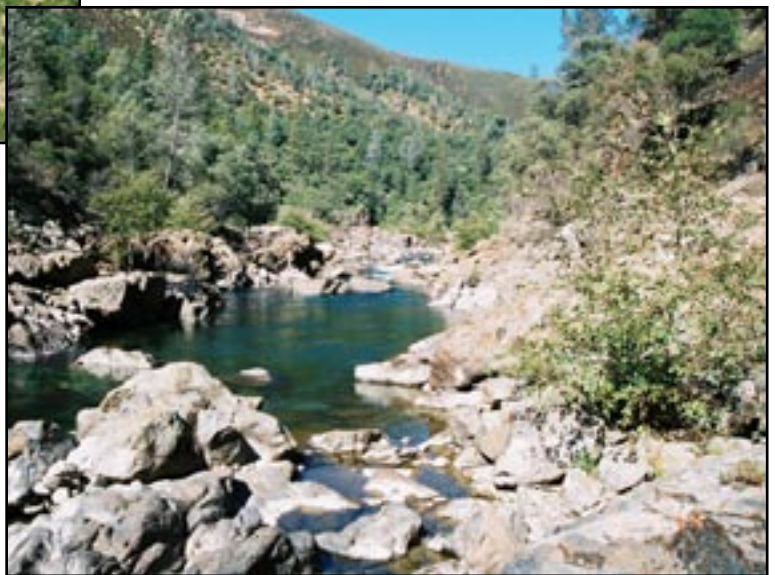
*River bank immediately
upstream from copter LZ.*

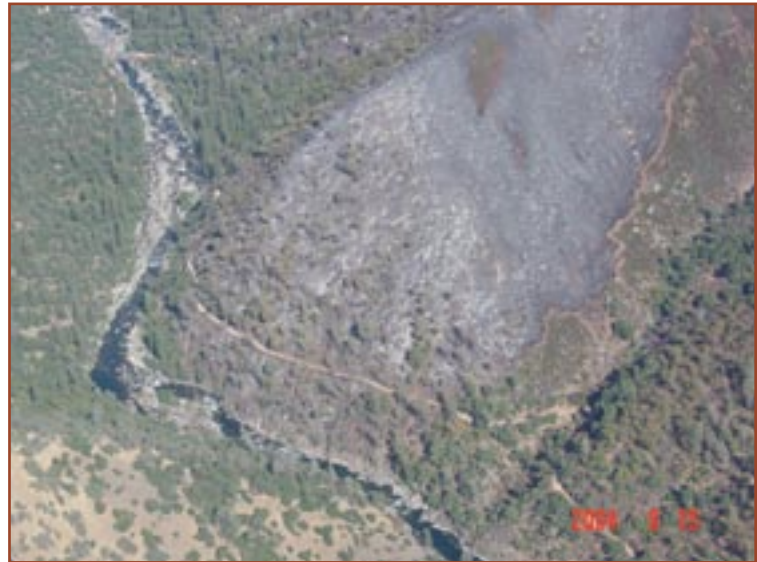
*Tuolumne River,
fire origin, accident site.
Lumsden Bridge is at
top of photo.*

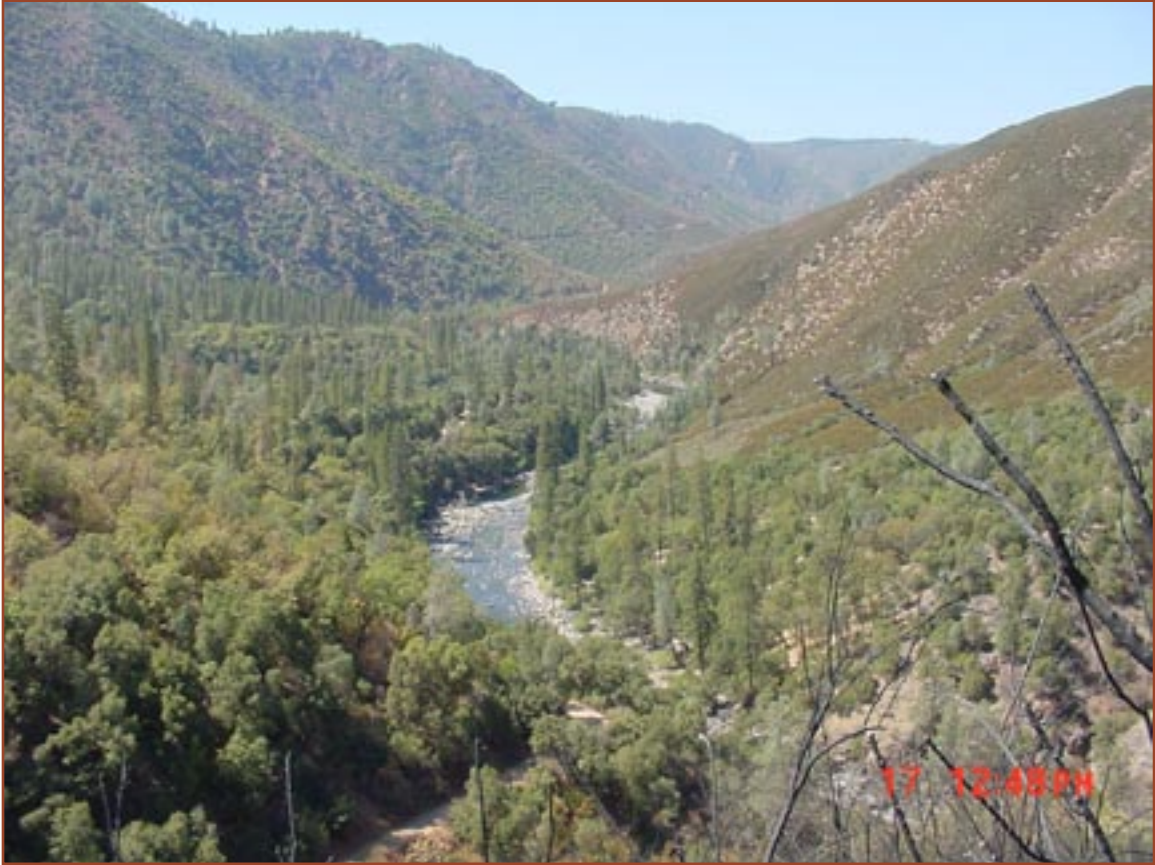
Photo D-2: Tuolumne River Canyon looking downriver to the west. Photo was taken approximately 150' above accident site. Accident site is not visible in this photo.

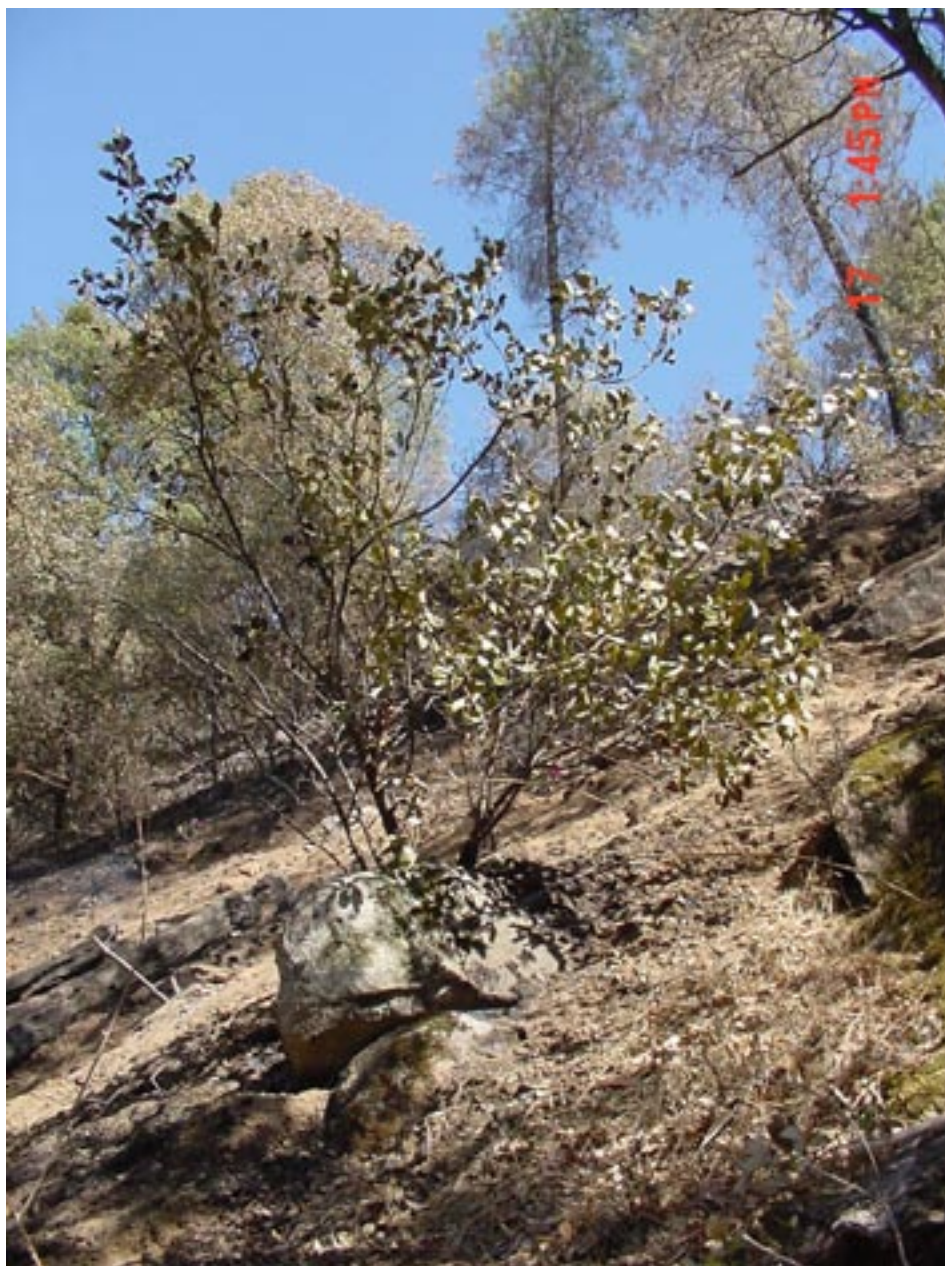
*Photo D-5.
Underburned
toyon brush.*

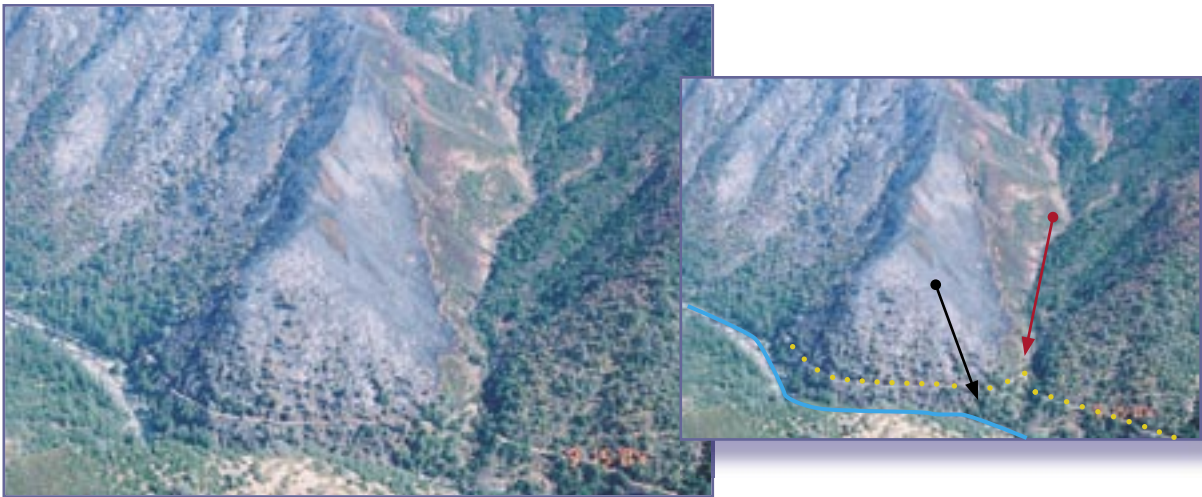
Photo H-1. View of lower fire area and accident scene. Tuolumne River (blue line) runs from lower left side (upstream) to lower right of photo (down stream) with north to the left of the photo and south to the right. Photo taken generally from west to east. Drew Creek (red arrow) is visible to the right of burned area. Lumsden Road (yellow dotted line) runs above the river on the southeast side and is visible near the bottom of photo. Accident site (black arrow) is located on the slope below the road and just above the river, just inside the right flank.

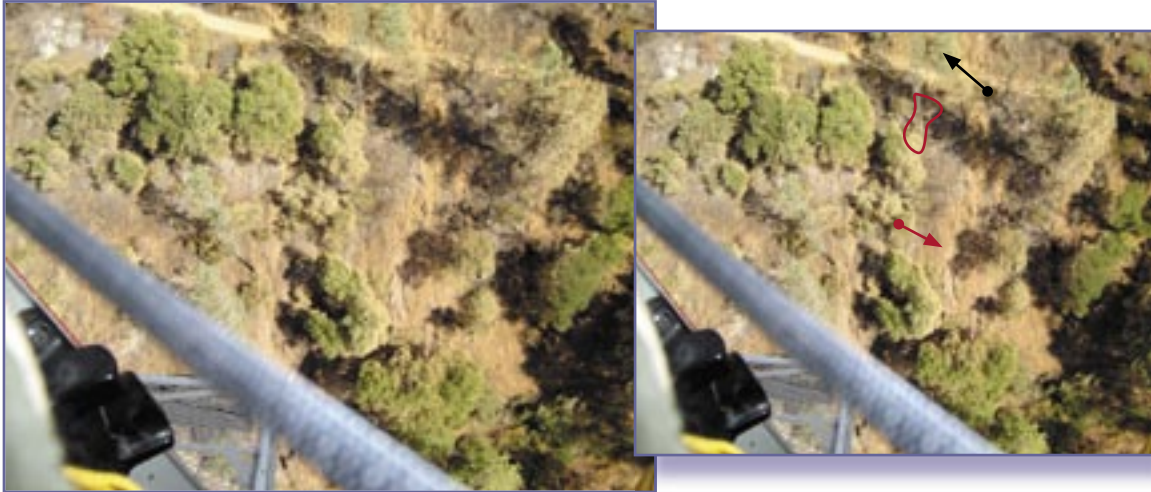
Photo H-2. Photo of accident site with Lumsden Road visible in upper photo. Line construction left the road between gray pine and large oak below the road (black arrow) in upper right corner of photo. Dark ash area (red line) below and to the left of gray pine is remains of brush patch. Line construction came around right edge of this burned area and underneath it prior to turning down-slope again. Victim's body recovered in shadow located to right of center (red arrow), right and above burnt logs on hillside.

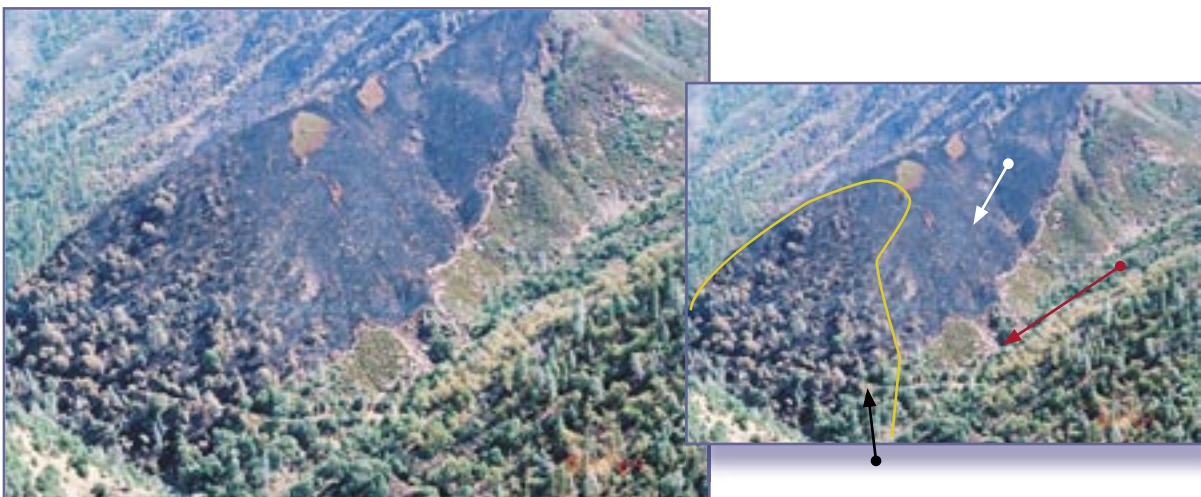
Photo H-3. View of west aspect slope (yellow line) shown in lower left corner. Drew Creek in right of photo (red arrow). South aspect (white arrow) above Drew Creek visible above it. Ridge and fuel transition from west aspect to south aspect visible just left of center. Accident site (black arrow) below road along right flank near bottom of photo.

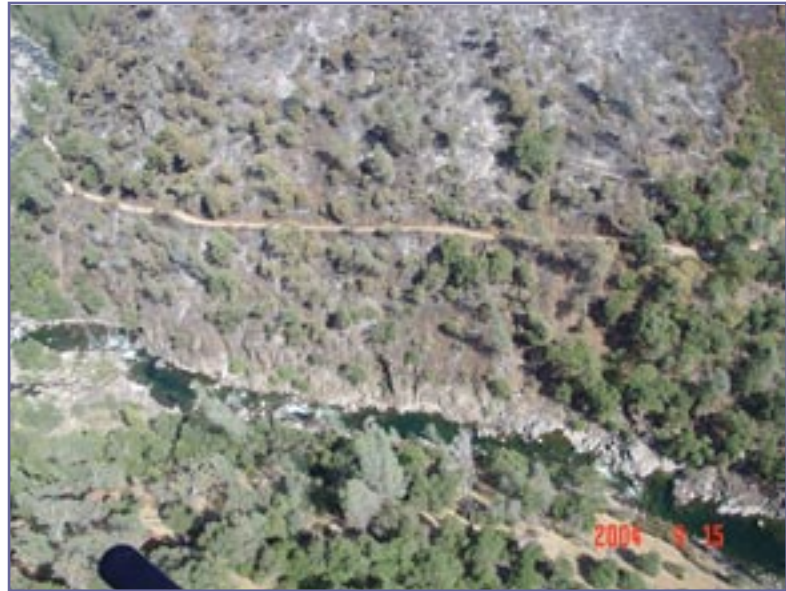
Increased physical barriers such as rock outcrops and chimneys with sparse fuels also restricted fire spreading across the slope below the road. Burn indicators on the right flank below the road are consistent with restricted lateral spread due to topographic and geologic features. Lower on the slope, near the river, burn indicators show that the right flank of the fire was originally backing slowly in sparse grass and leaf surface fuels and into a light wind. As this lateral spread continued across the slope, burning debris rolled down-slope into the chutes formed by the rock formations below. In some cases evidence of large burning logs and limbs was observed to have rolled down-slope to the river area. Most of this rolling debris occurred after the fire front had moved through the area.

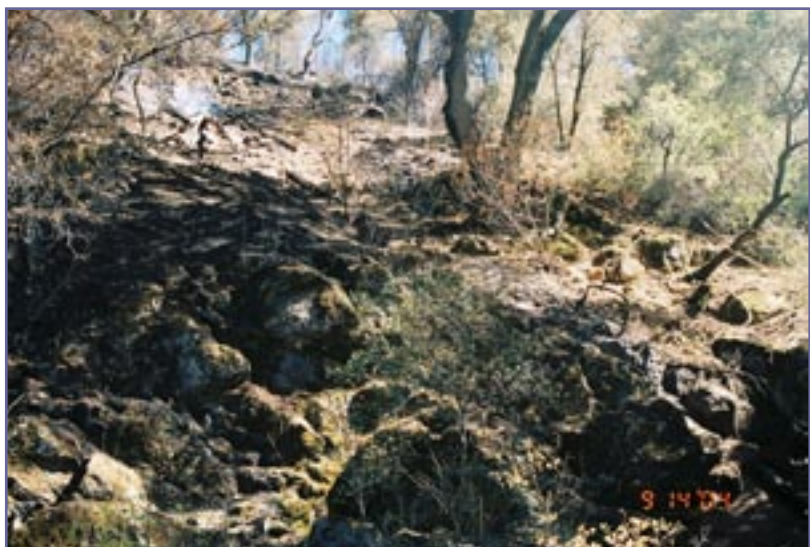
Burn indicators including cupping on low lying brush, protection indicators on and around rocks, degree of burn and leaf freeze showed that on the lower one quarter of the slope below the road, a slow burning backing fire continued to burn cross-slope towards the accident site. Burned fuels indicated that prior to reaching the general accident site the backing fire moved into a stand of low oak trees and brush with openings covered by more continuous leaf litter and pine needles. This increased continuity in fuels from sparse grass to leaf litter allowed the fire lower on the slope to continue its spread south.

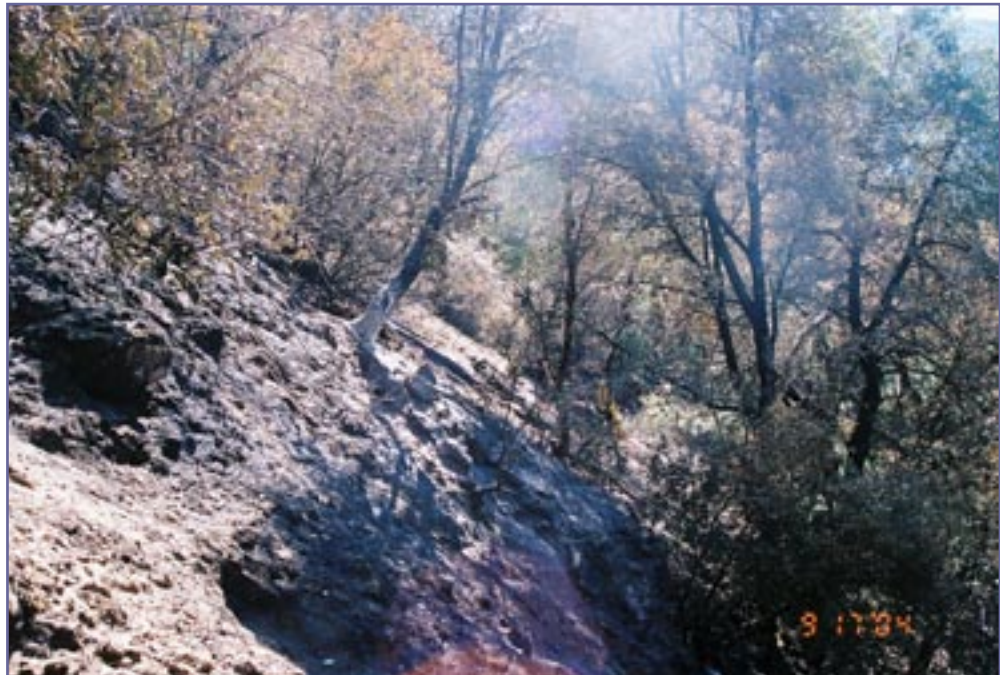
Reports from the members of Helitack Crew 404 indicate that they chose the line location at the general accident site to take advantage of a break in the brushy fuels. This is consistent with the ash and burned stem remains at the site that indicates a decrease in brushy fuels in this area. During examination of the accident site, several locations were found where the surface fuels had been protected by moving objects. In these locations, the surface fuels consisted of sparse grass and a thin layer of leaf debris.

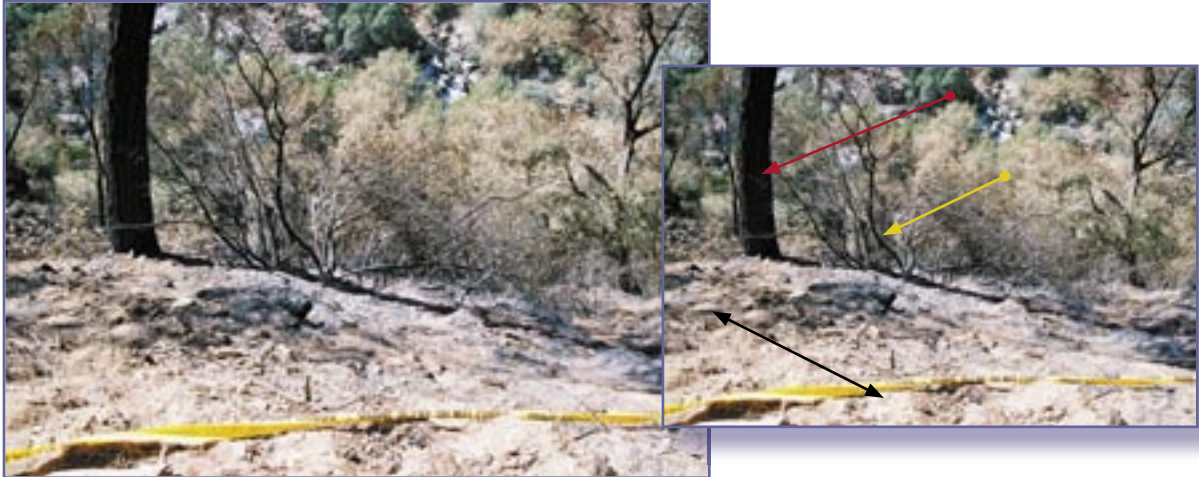
Photo H-8. View from road at top of line construction (black arrow) down-slope towards gray pine (red arrow) and toyon bush (yellow arrow) which are located at bottom edge of fired out area and at upper edge of brush patch which sustained fire run.

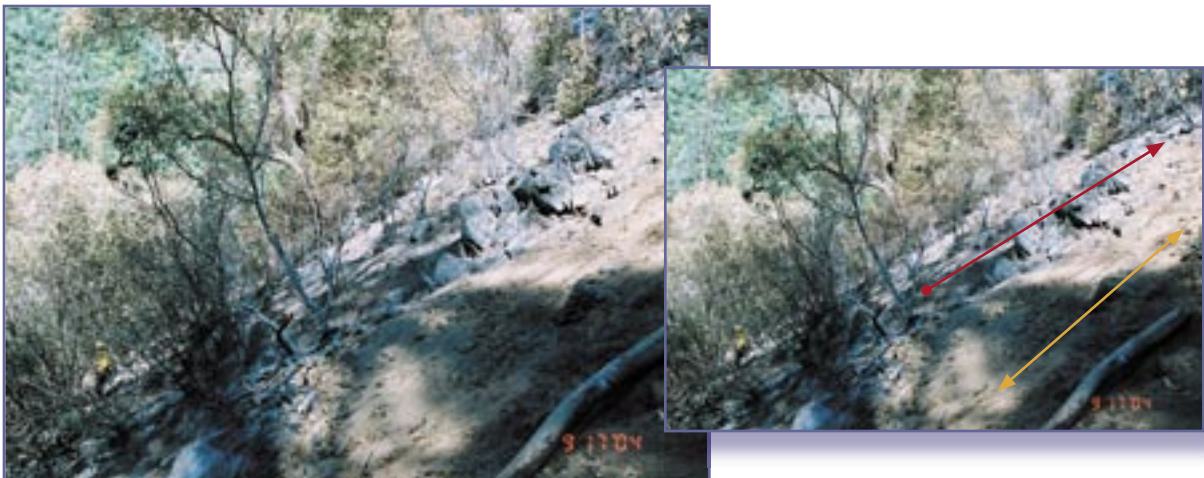
Photo H-9. View of lower end of brush patch showing beginning of run (red arrow) in brush up-slope. Constructed handline (yellow arrow) located in right lower corner.

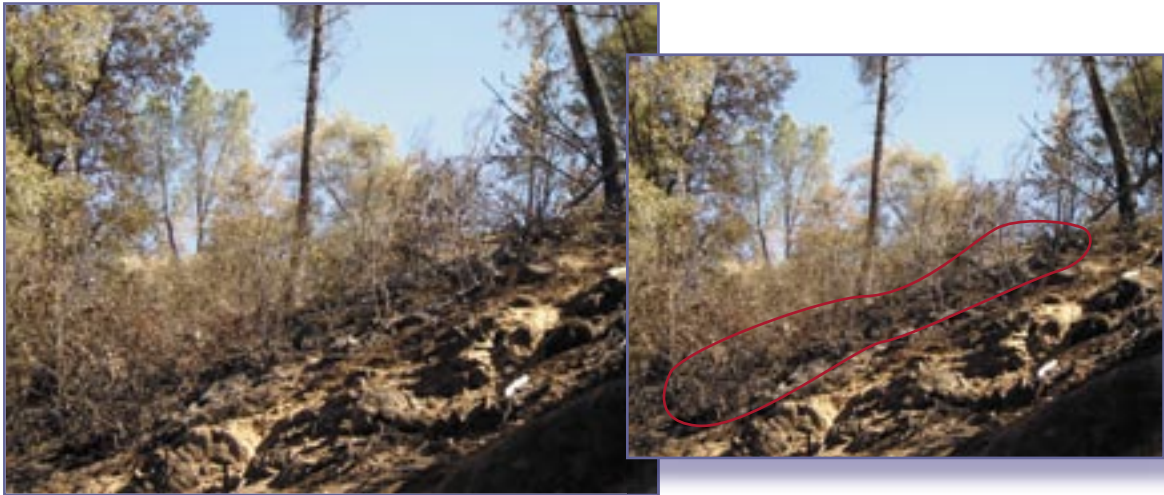
Photo H-10. View of brush patch (red line) which burned off just inside line location directing convective heat towards the upper end of the line near the road.

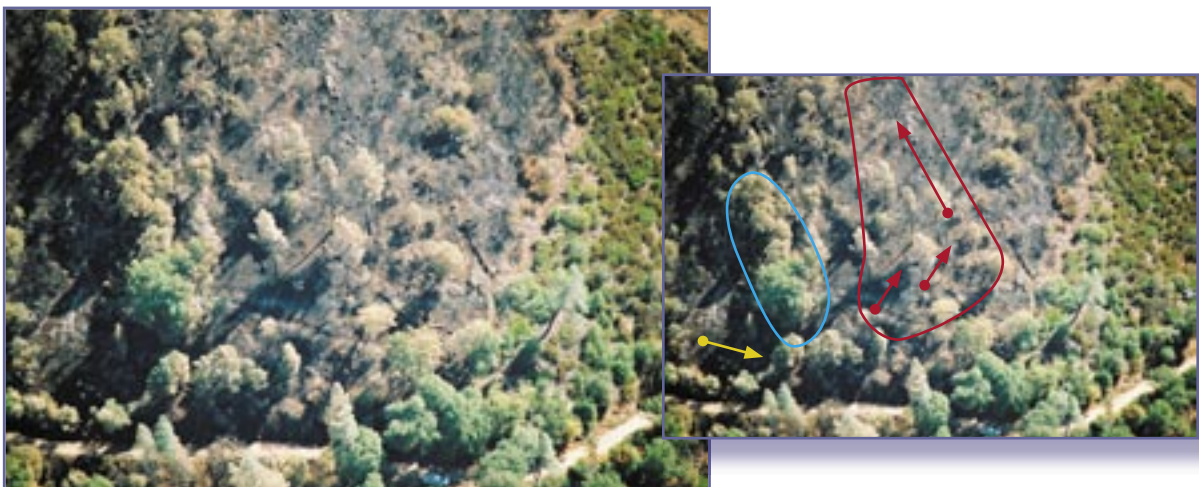
Photo H-11. View of area above the road and above accident site. Green trees visible to the left edge of photo above road is area of possible helicopter water drops (blue line). In center of photo is area which burned hot (red line) and rapidly (spread direction shown in red arrows) prior to and during accident events. Burning snag (yellow arrow) was located below and to the left of bright green tree above road in lower left corner of photo.

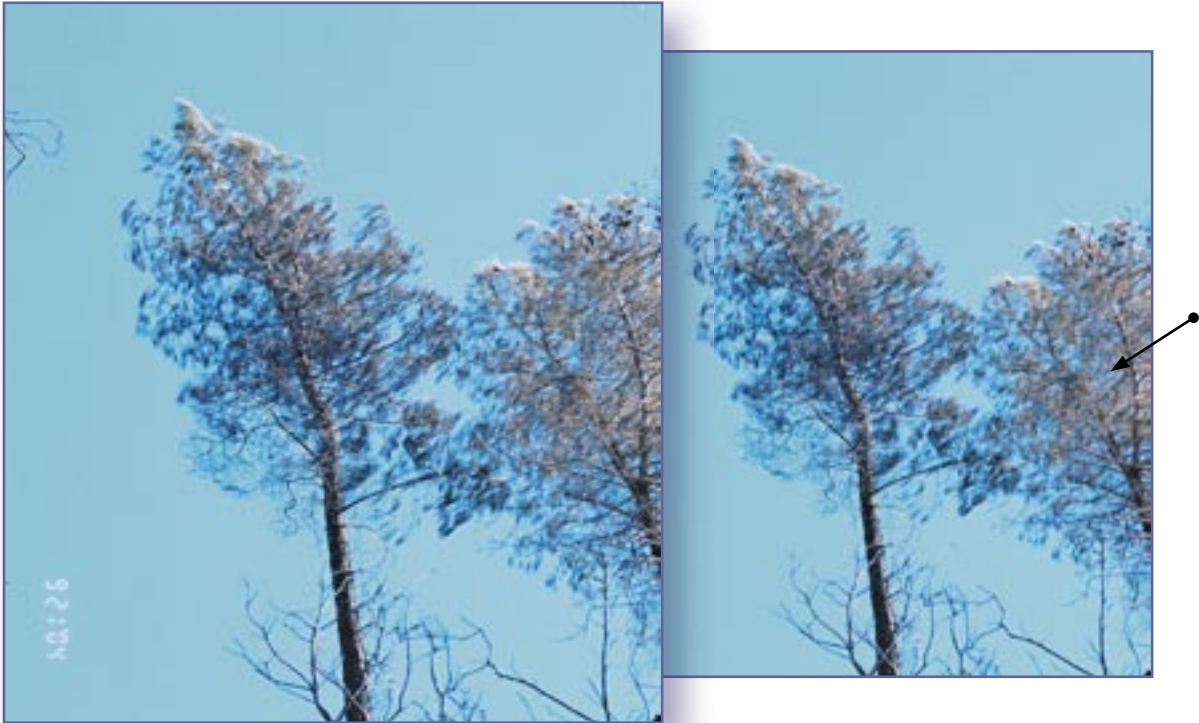
Photo H-15. Gray pine located along dividing ridge between Drew Creek south aspect and accident site west aspect slopes. Needle freeze (black arrow) and scorch height on pines indicates severe burning activity and wind directions curling from the west aspect up-slope and east, turning up-slope and to the north on the south aspect. Photo taken looking generally west to east.

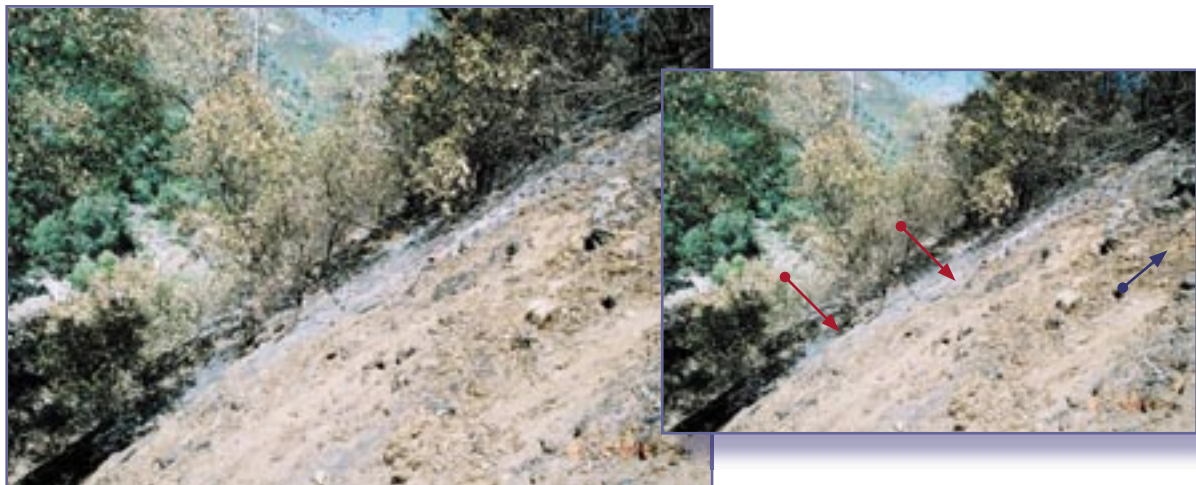
Photo H-18. View from lower third of slope below the road at accident site looking from south to north cross-slope towards the direction where Helitack Captain Winger indicated the fire run had come from (red arrows). Chain saw work visible on right edge of photo and near center of photo (blue arrow).

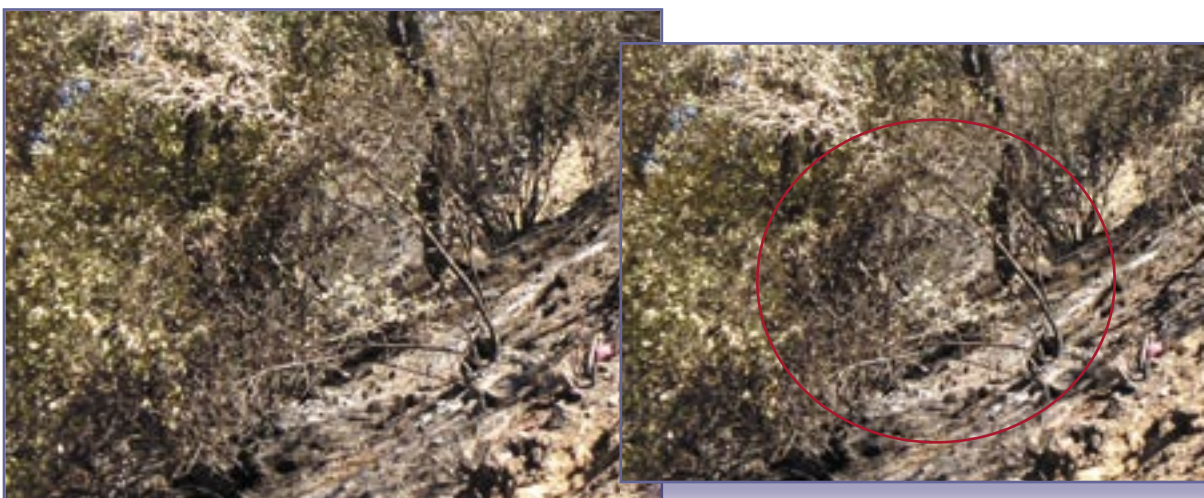
Photo H-20. View from mid-slope below road in accident scene looking from south to north cross-slope towards bottom of brush patch showing transition area (red circle) from surface fire to brush fuel fire.

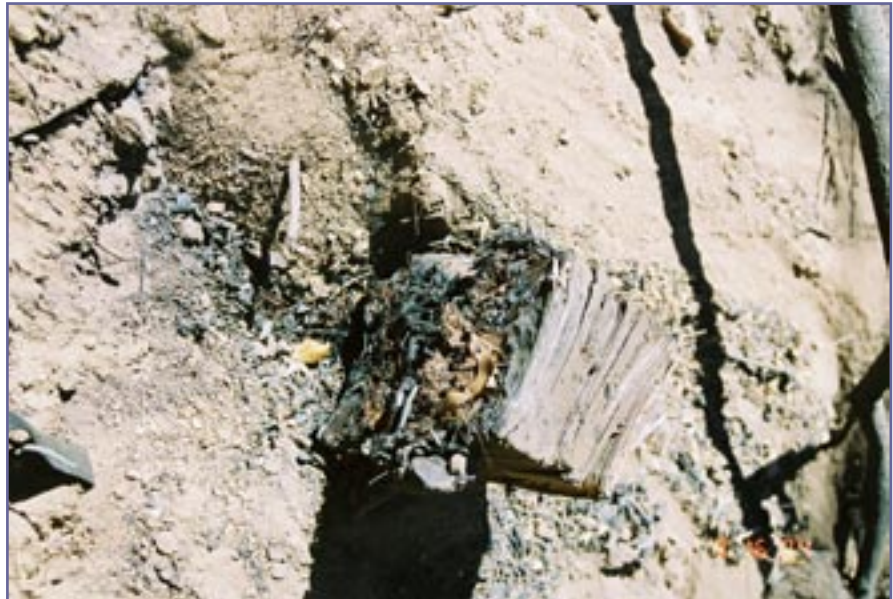
Photo H-23. Photo of unburned vegetation located under loose rock about 2.5 feet up-slope from body recovery site, indicating that this area was not burned at time rock slid to this location.

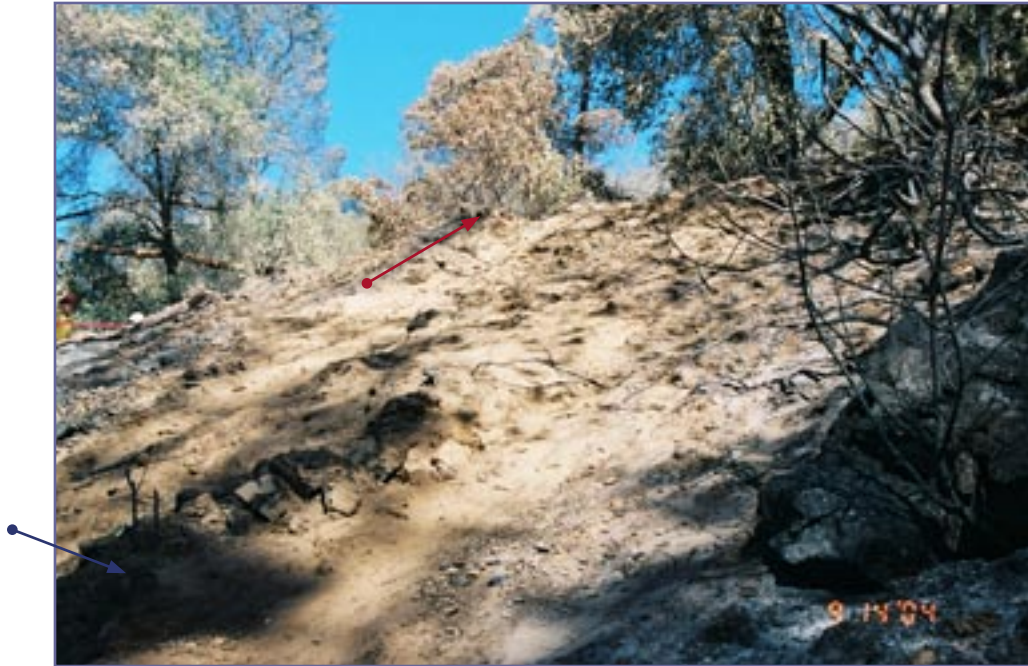
Photo H-24. Burned debris associated with Firefighter Schicke highest on slope located in lower left corner of photo (blue arrow). Road (red arrow) shown 23 feet above at end of dirt slope.

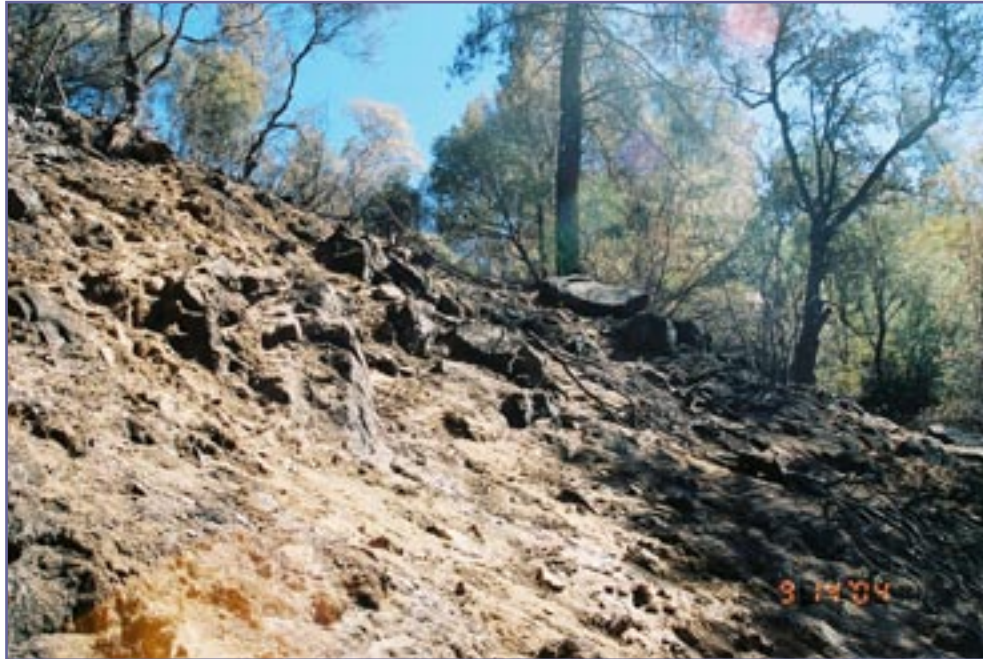
Photo H-27. View up-slope and from line location showing rock outcrop, located above body recovery site that line passed over.
