California Department of Forestry and Fire Protection

Review Report of Serious CDF Injuries, Illnesses, Accidents and Near-Miss Incidents

Engine Crew Entrapment, Fatality, and Burn Injuries

**Cedar Fire
CACNF-003056
CACSR-000132**

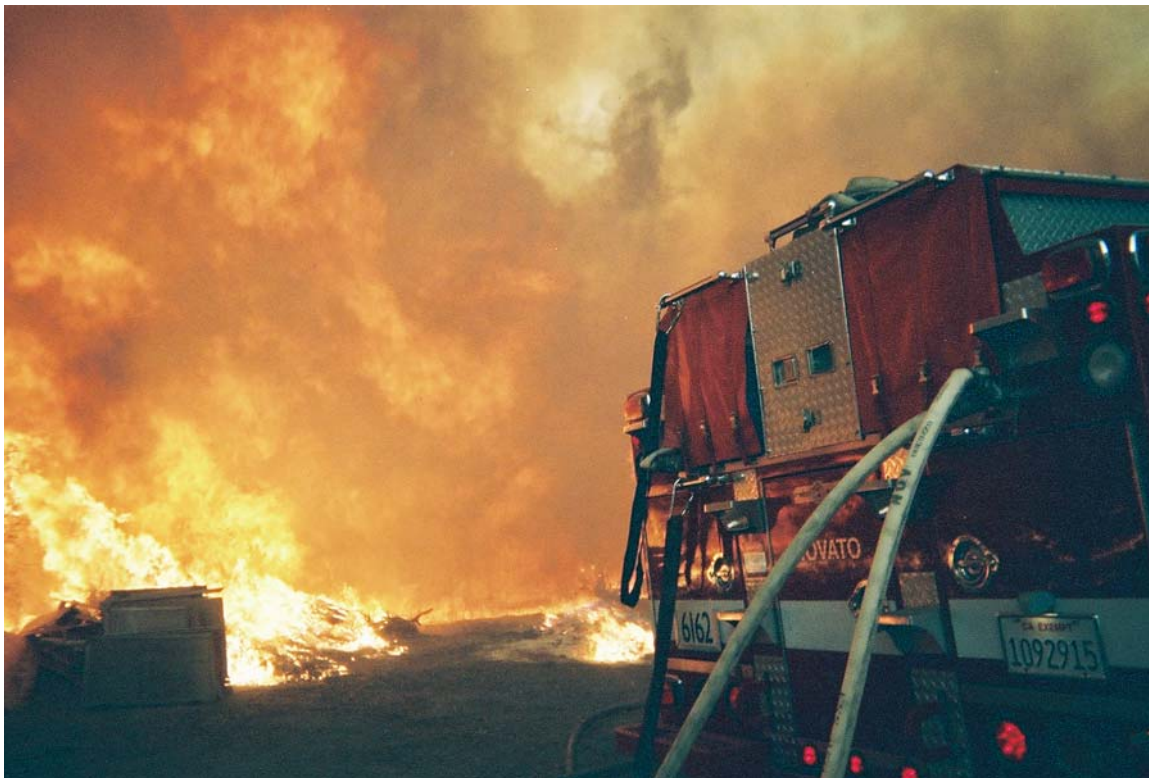
Picture taken by Engineer Kreps as he steps out from behind the cover of the passenger side of the engine.

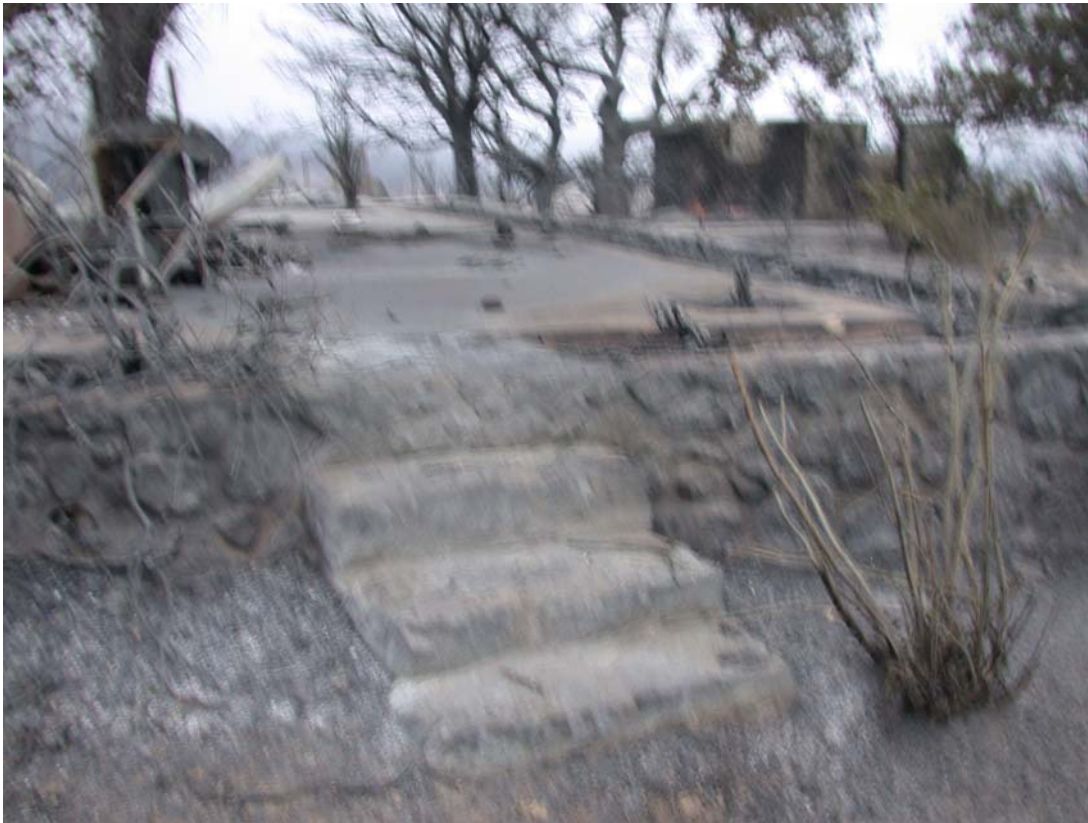
Steps which the crew members used to get up onto the patio.

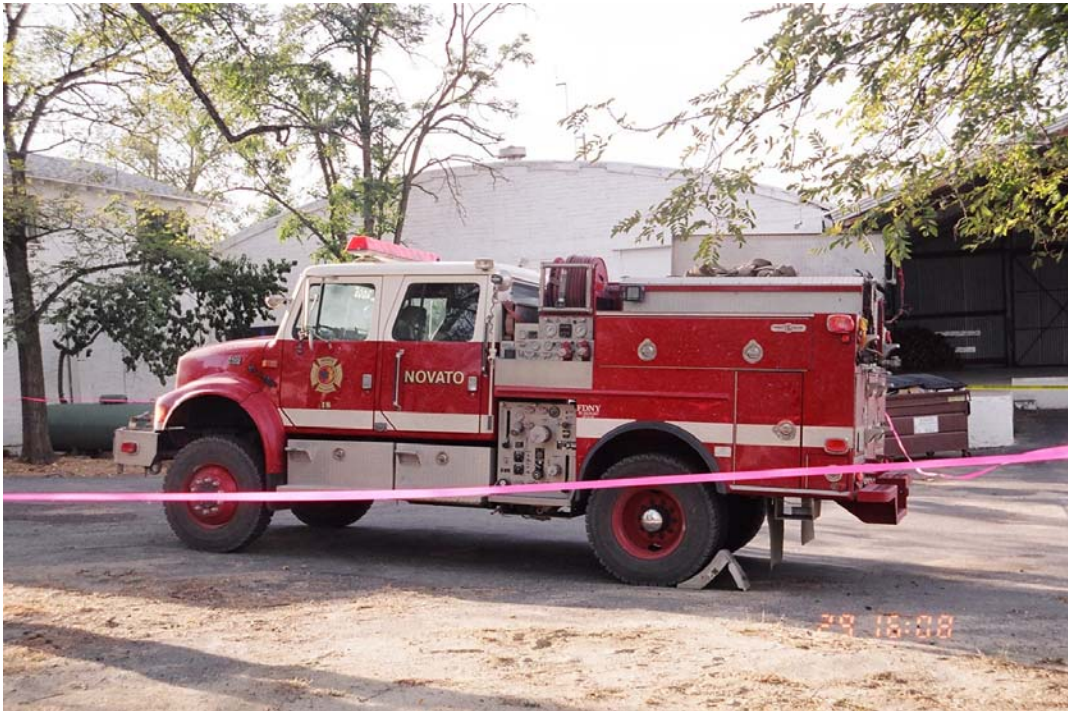
Engine 6162 at initial medical treatment area at 3:08 p.m. on Oct. 29, 2003. Note the time stamp on the photograph is one hour ahead of the correct time.

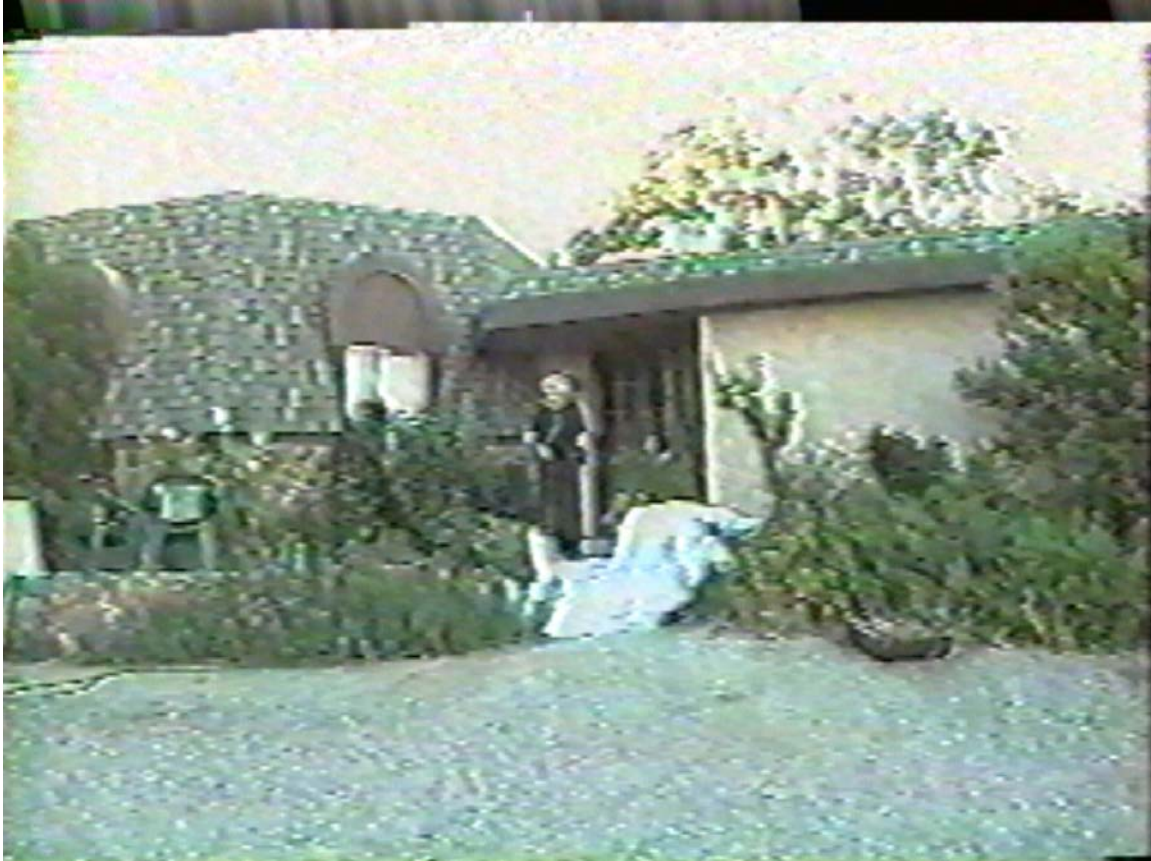
Photo from the 2001 Lis family video of 920 Orchard showing the combination roof covering style, the house front door, the unimproved dirt surface driving area, and the landscape vegetation as it existed in 2001*

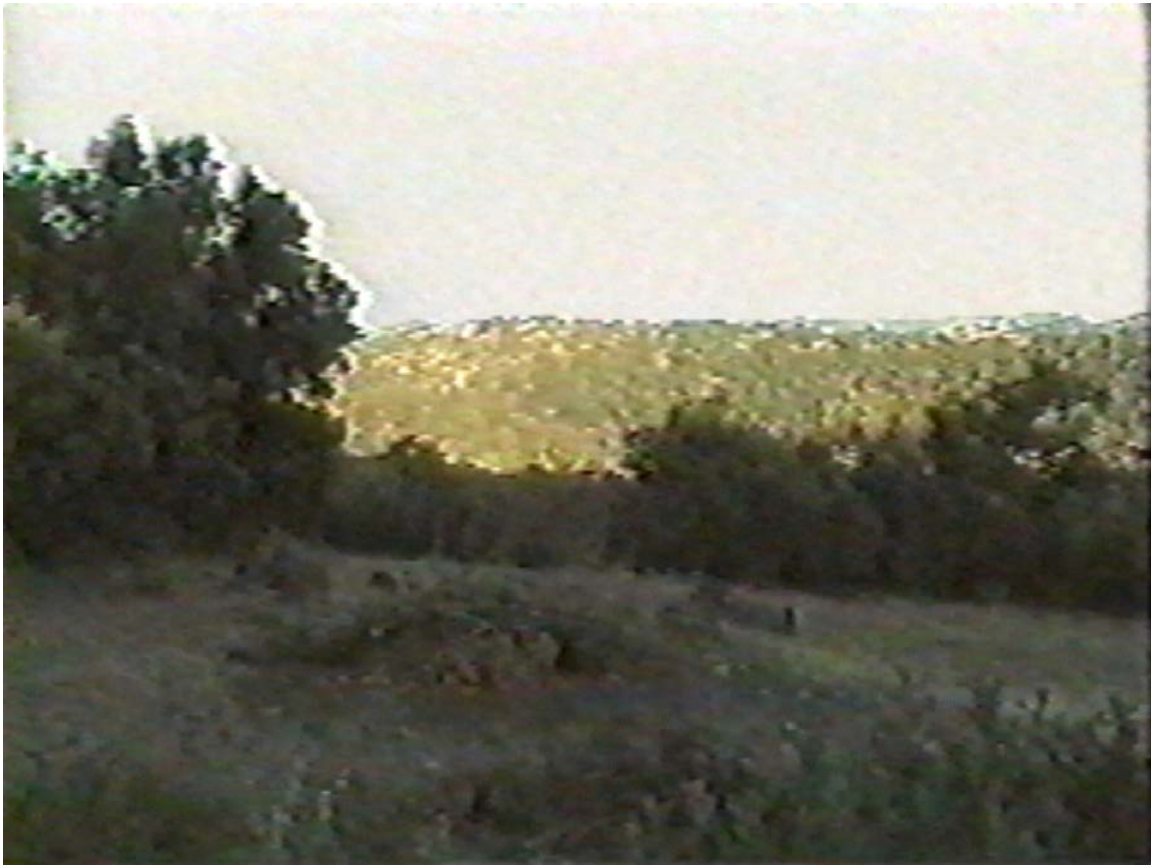
Photo from the 2001 Lis family video looking southwest from the dirt driveway at the southern end of the large brush clearance area below the house. The image is recorded from the general area of where Engine 6162 was parked.

To the south of the house the brush clearance extended approximately 100 feet, or approximately 40 feet behind Engine 6162. There was approximately 70 feet of brush clearance east of the house, which was the leeward side of the house during the entrapment. Due east from the northern end of the house, beginning approximately 30 feet east of the house deck, a large unburned island of oaks extends along the south side of the driveway down to Orchard lane, an area approximately 280 feet long by 50 feet wide (see Figure 4). There was no consumption of the oak tree canopy in this area and only partial burning of the surface fuels. In this area closest to the house, the unburned surface fuels consisted of oak leaf litter. The grass, if any, had been cleared and there were no ladder fuels below the tree canopies. To the north of the house the brush fuel bed began along the north side of the driveway, 115 feet north of the house.

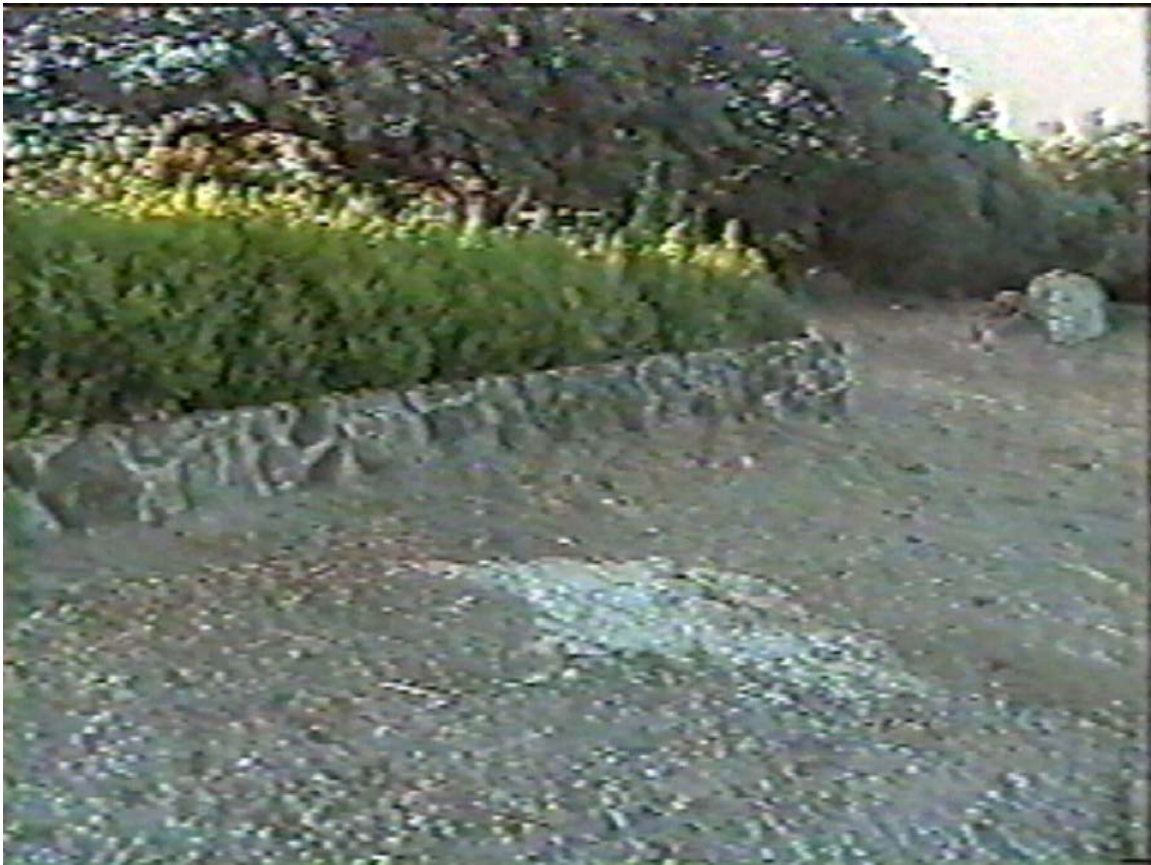
Photo from the 2001 Lis family video looking southeast from the dirt driveway. Brush clearance to the south of the house just visible to the right of the large boulder. The box hedge and rock wall next to where Engine 6162 was parked is in the center of the image.
