Accident Investigation Report

CDF HELITACK CREW 404 BURNOVER

Tuolumne Fire

CA-STF-2191

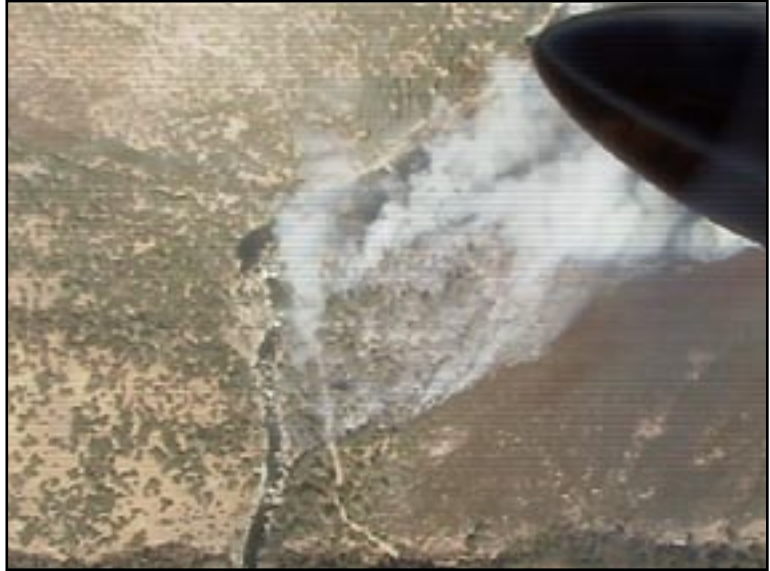
*Fire origin along
Lumsden Road
(parallel to the river).*

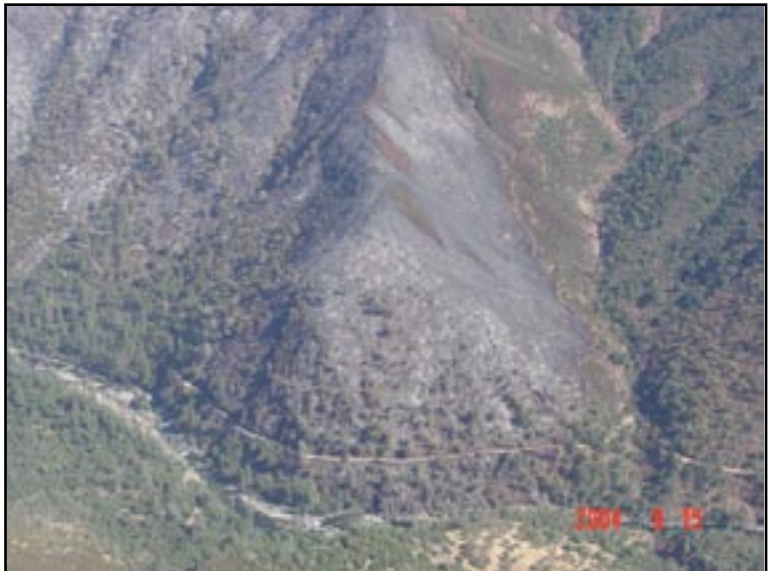
*Rocky river
bank and
steep slopes
below the road.*

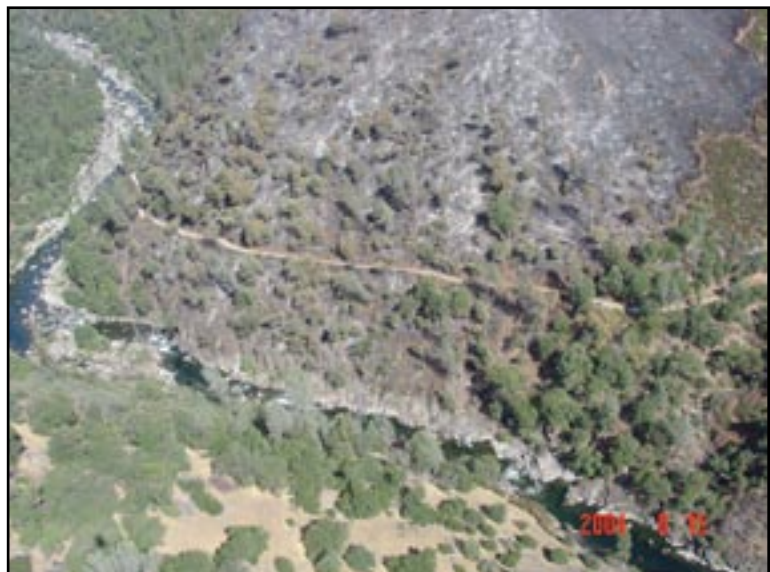
*Right flank of fire.
Drew Canyon is at
bottom of photo.*

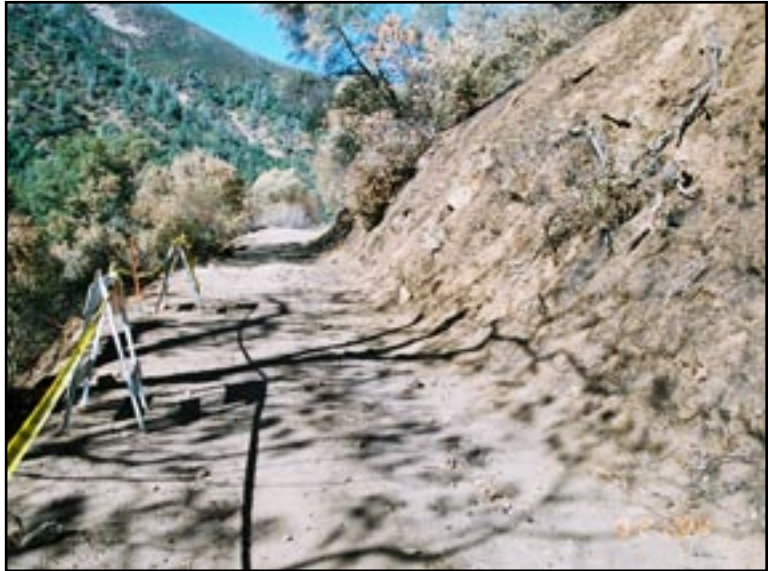
Lumsden Road looking west from fireline anchor point. Line construction is to the right at the orange flagging.

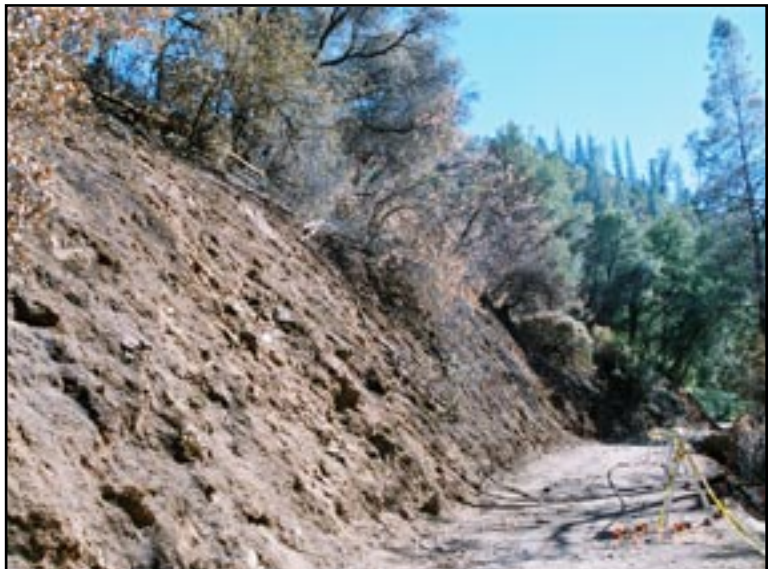
Lumsden Road looking east. Fire line anchor point is at orange stake just past second sign. Constructed fireline is downhill from the road.

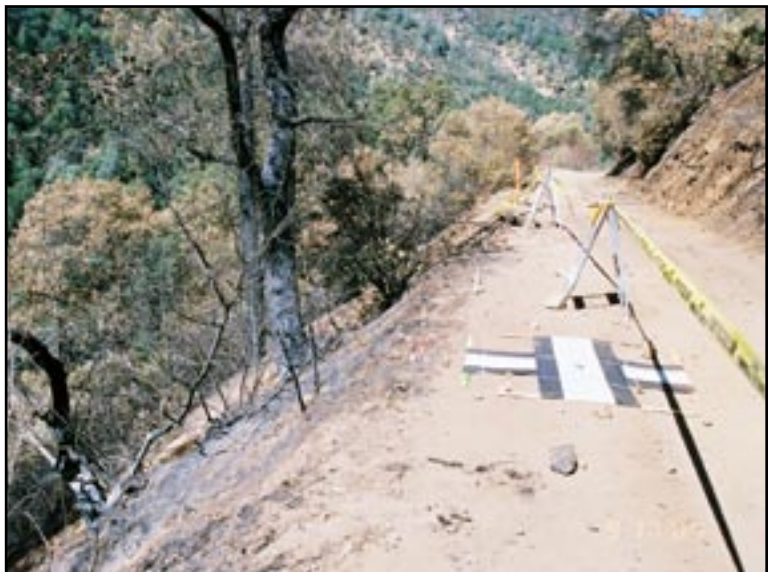
*Fireline construction area.
Lumsden Road is to right
of photo. Rock outcropping
is in center of photo.*

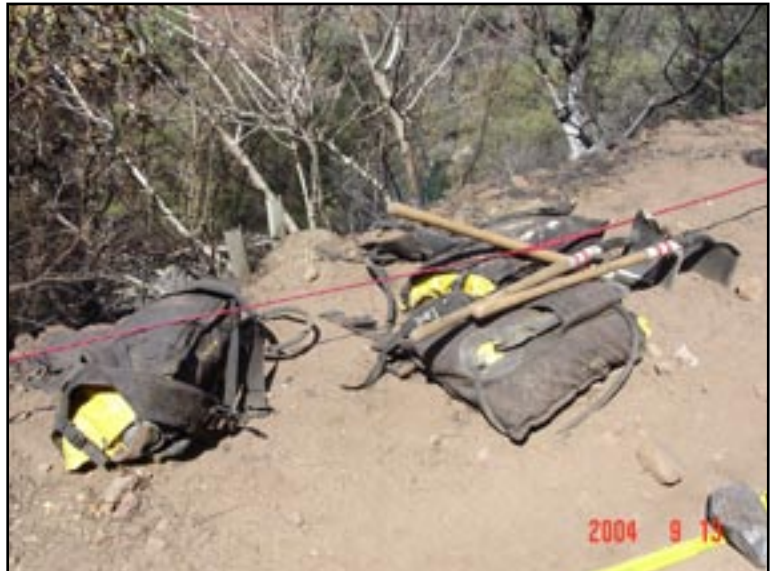
*Bladder style back
pumps and "Rhyno"
scraping tools.*

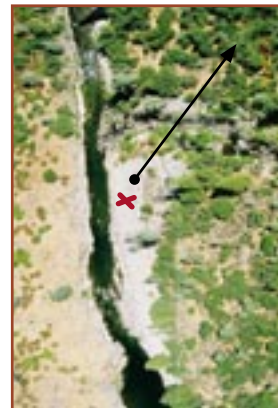
The seven firefighters from Copter 404 hiked to Lumsden road (black arrow shows walkout route) after being dropped off on gravel bar landing zone (red "x").

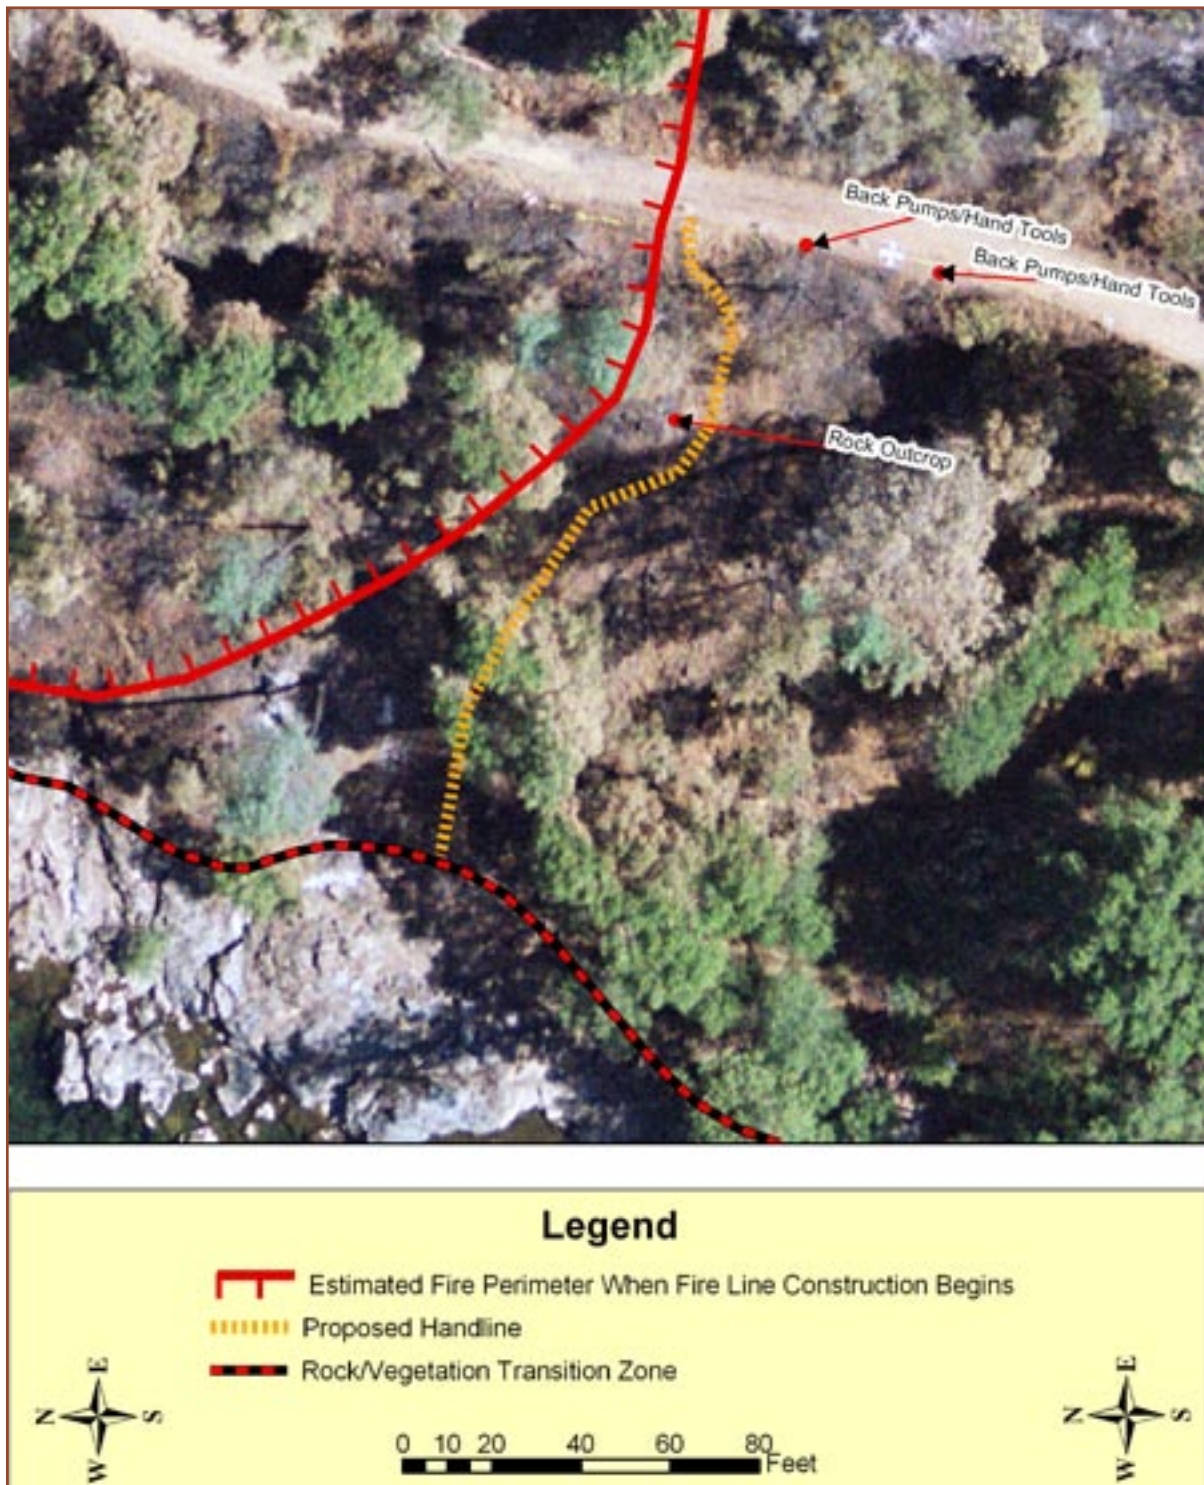
Planned fire line construction.

require constructing underslung line if they went direct. HC Winger made the determination that constructing a scratch line from the road downhill to the river would be simple and quick to accomplish. His plan was to construct indirect line parallel to the fire edge and then cut off the underslung portion by dropping straight down to the river and firing out the intervening fuel.

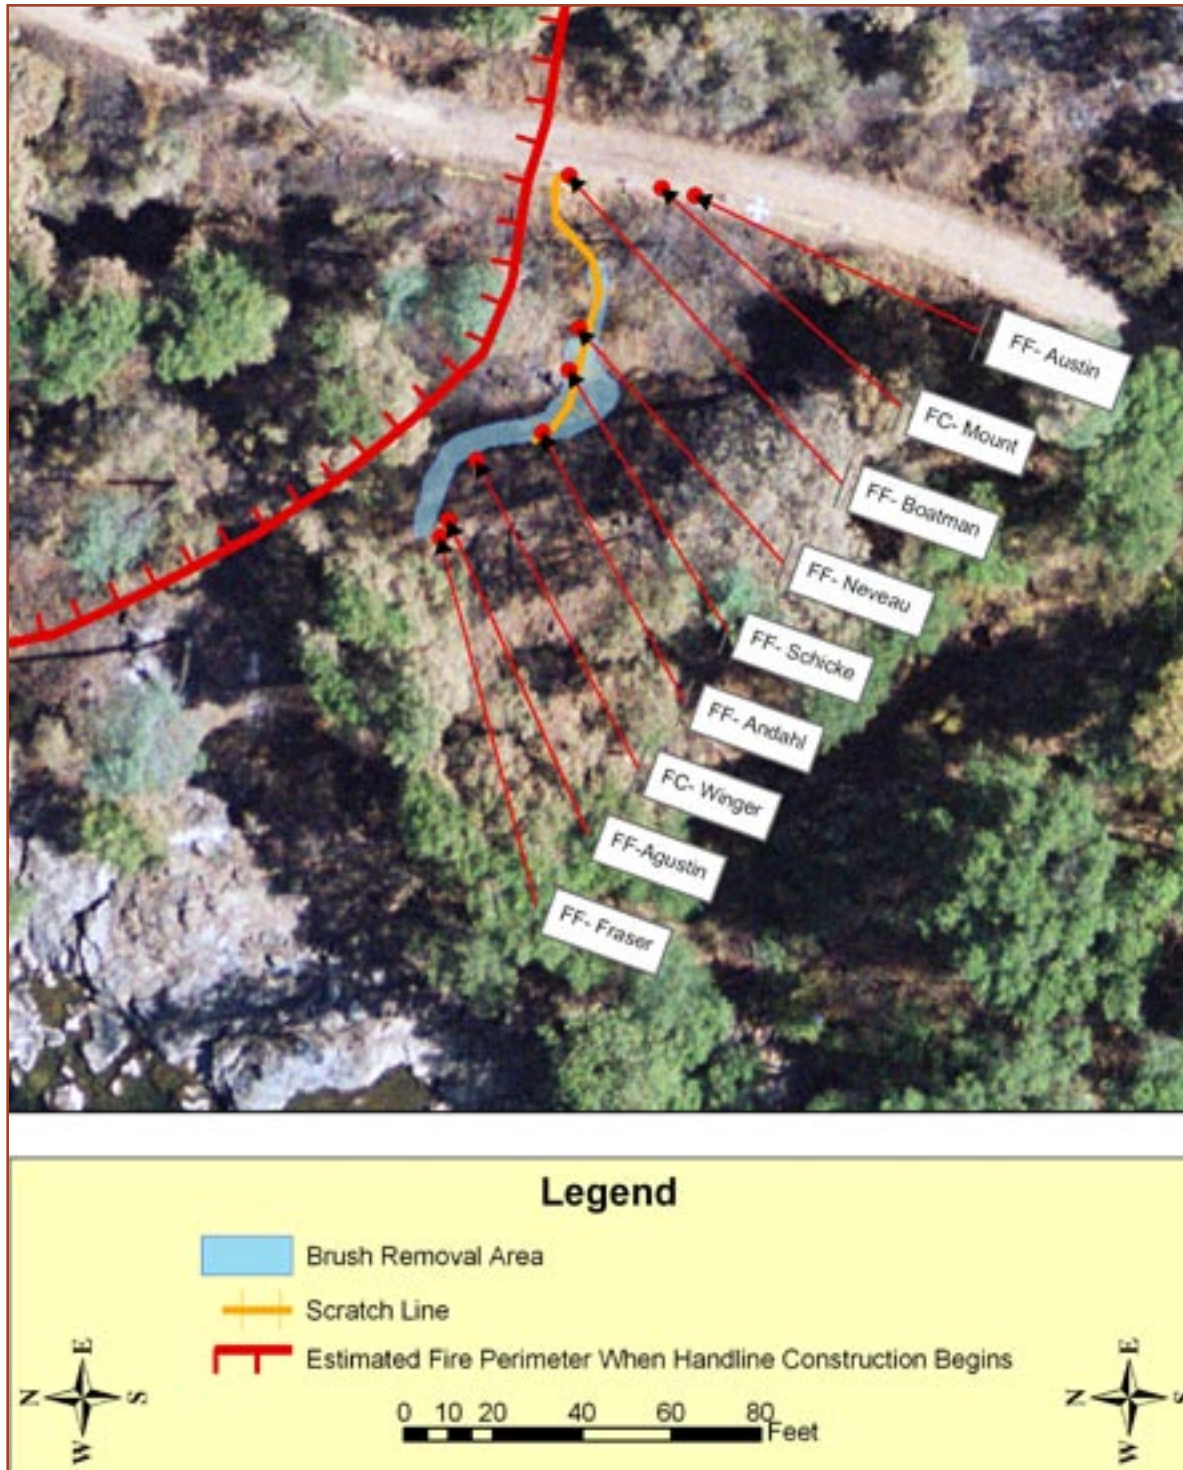
Crew Location Prior to Flareup

Firefighters then observed what they described as a “minor” flutter in the wind. According to statements made to interviewers, Captain Winger addressed the three upper firefighters (Schicke, Neveau, Boatman) to “grab the back pump and just make sure that holds as you go down; look for spots as you go; lookout.” FF Boatman volunteered to take this assignment and returned up the fireline to the road, he did not hear HC Winger say to be a lookout.

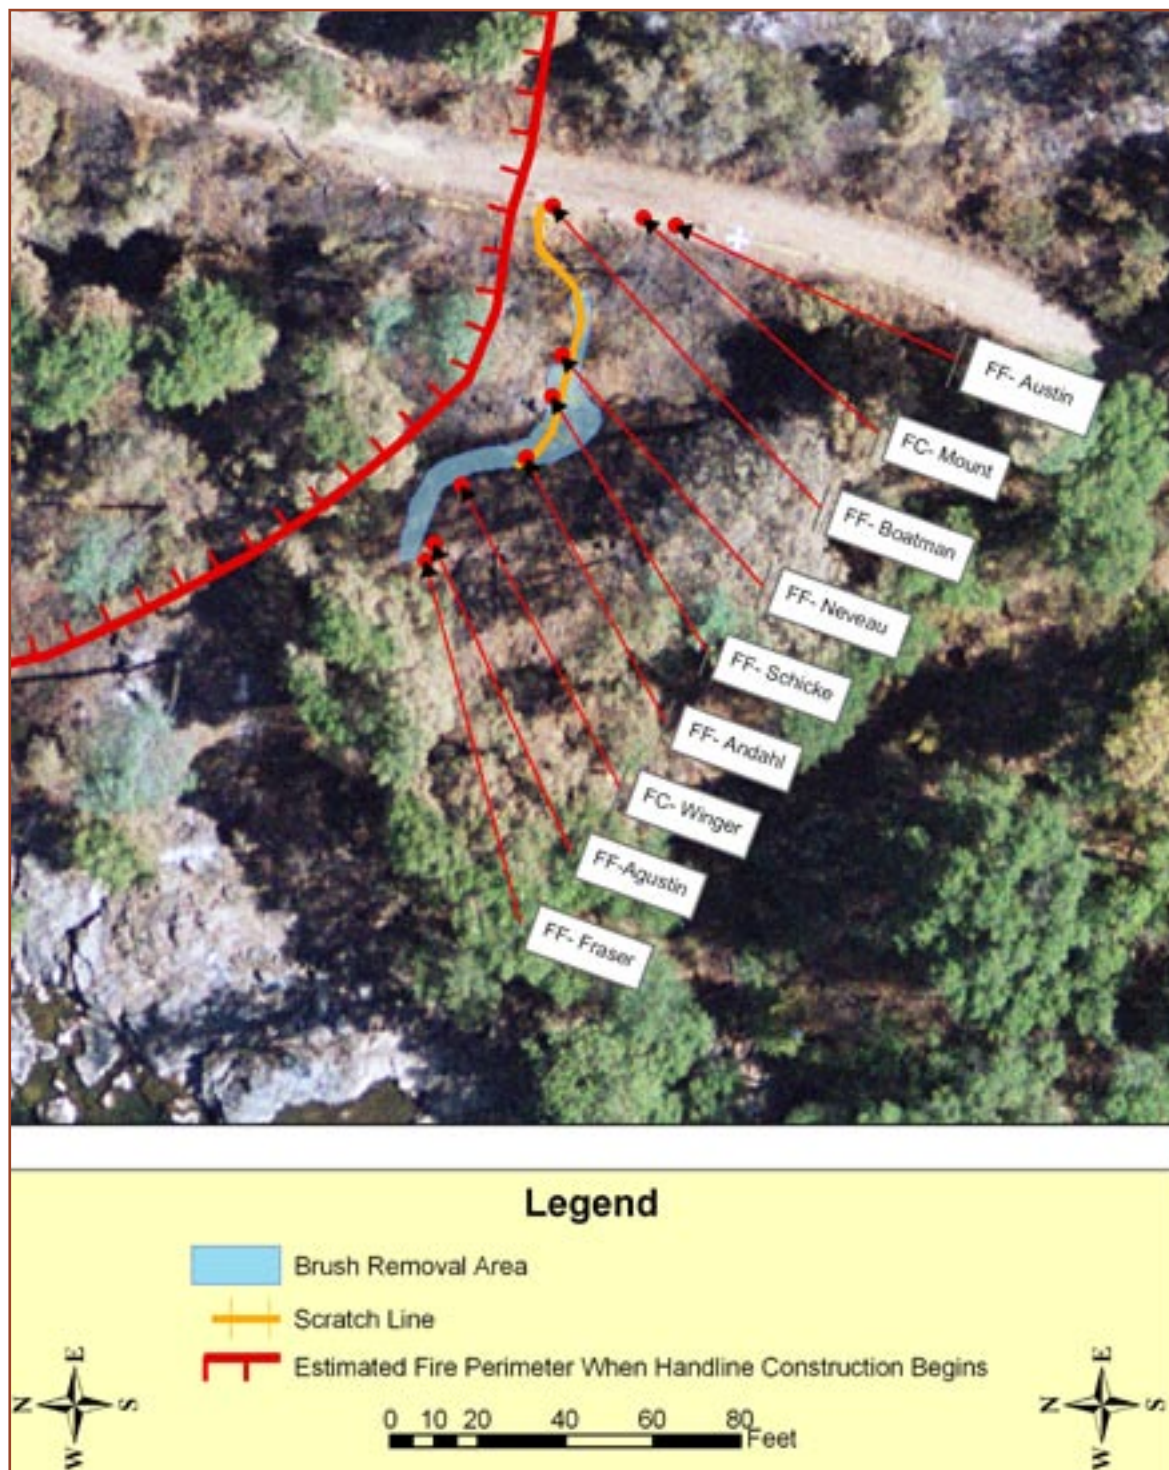
Personnel Location Prior to Flareup

- The firefighters did not see a safe route through the burn to the river.
 - The only other option to access the river would have been to go down through the green. The only place to do that quickly was the same opening they used to construct fireline.

- The steepness of the 80 to 120 percent slope combined with loose soil, rock out crops and drop offs made travel slow and difficult. This situation was a significant factor in the selection of the tactical options of downhill line construction.
- They did not consider withdrawing from the assignment.

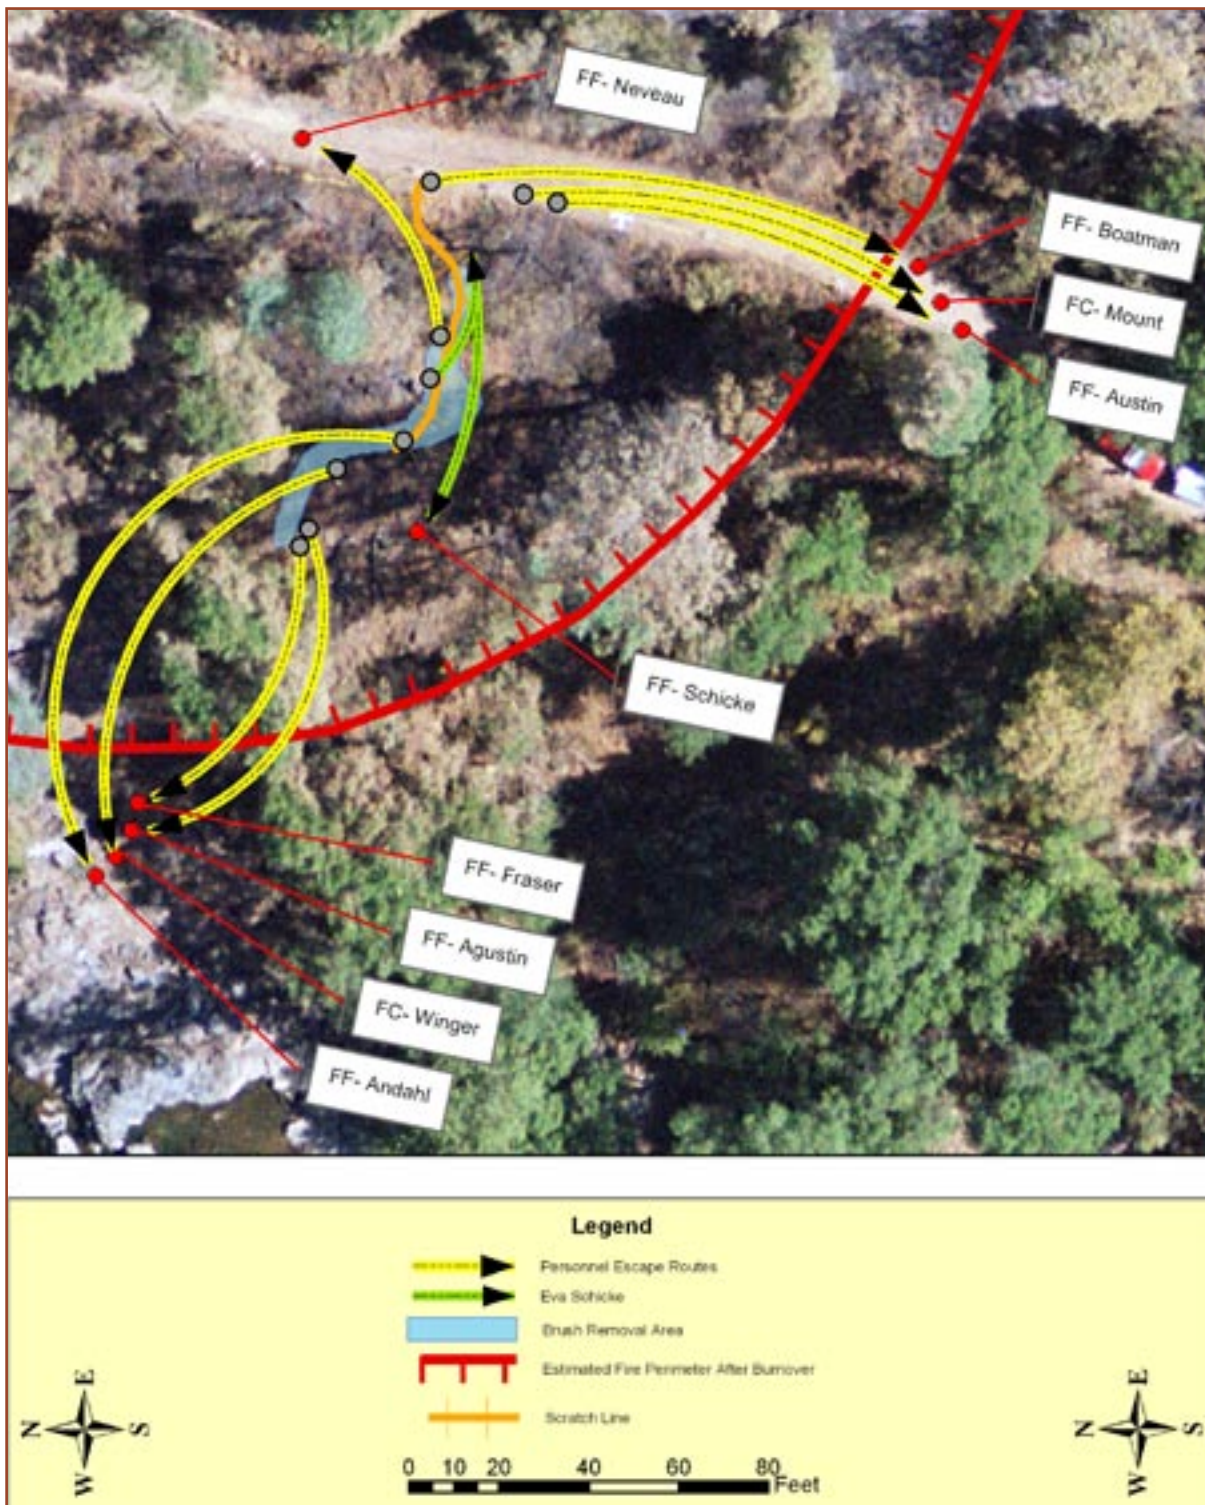
Post Burnover Crew Location

- ***The safety zone at the road was adequate, but required moving on the road into the green or into the black.*** FF Neveau reached the road and moved into the black. FF Boatman was on the road and moved into the green. Shelters were not deployed nor were they necessary. No injuries resulted once they reached the safety zone.

- ***The safety zone into the black was inadequate.*** Typically going into the cooled black is a primary safety zone. However, in this instance the black below the road proved to be too hot to remain without suffering injury. HC Winger and FF Andahl ran through flaming front into the black but believed it was too hot to stay there and turned downhill to reach the safety zone at the river. They did not deploy shelters either in the “black” or at the “river” safety zones. No injuries resulted once they reached the safety zones. Because of the flaming front and unburned fuel, escape into the black was not accessible to FF Neveau and FF Schicke.

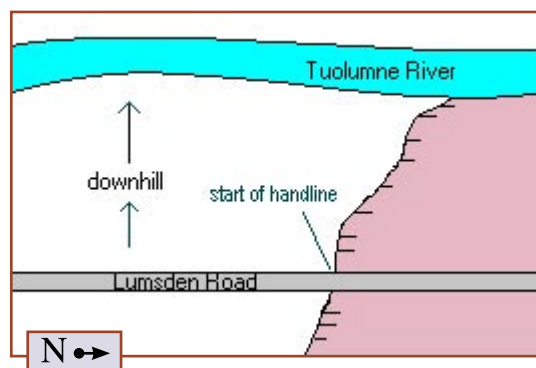
Upon arrival of the initial attack resources, the fire was backing down-canyon (toward the southwest) against an up-canyon wind. Flame lengths were described as less than 1 foot by the Incident Commander (IC) who drove to the right flank a few minutes before Helitack Crew 404 reached the line. Upon arrival, Helitack Captain (HC) Winger checked the lower right flank below Lumsden Road. The fire contoured down-slope but bent up-canyon toward the northeast. The fire below the road was aligned fairly closely with its extension above the road. The fire was creeping slowly down-canyon.

Figure 1: Fire alignment at time of initial ground attack. Pink area represents burn.

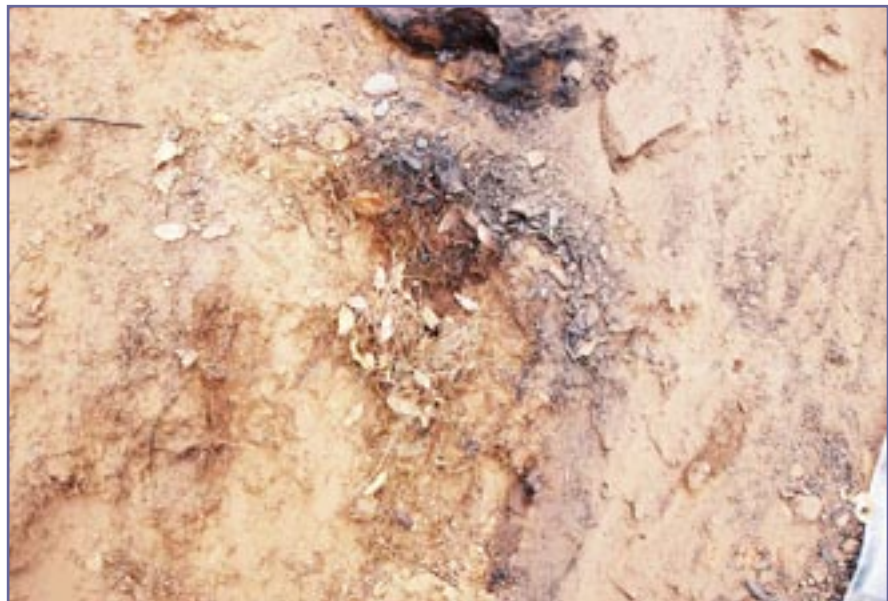
Photo H-23. Photo of unburned vegetation located under loose rock about 2.5 feet up-slope from body recovery site, indicating that this area was not burned at time rock slid to this location.
